# Mynydd Ty-talwyn Energy Park – Environmental Statement Volume III

Appendix 5.1: Preliminary Risk Assessment

Annex C – Site Reconnaissance Information

Project reference: 663870

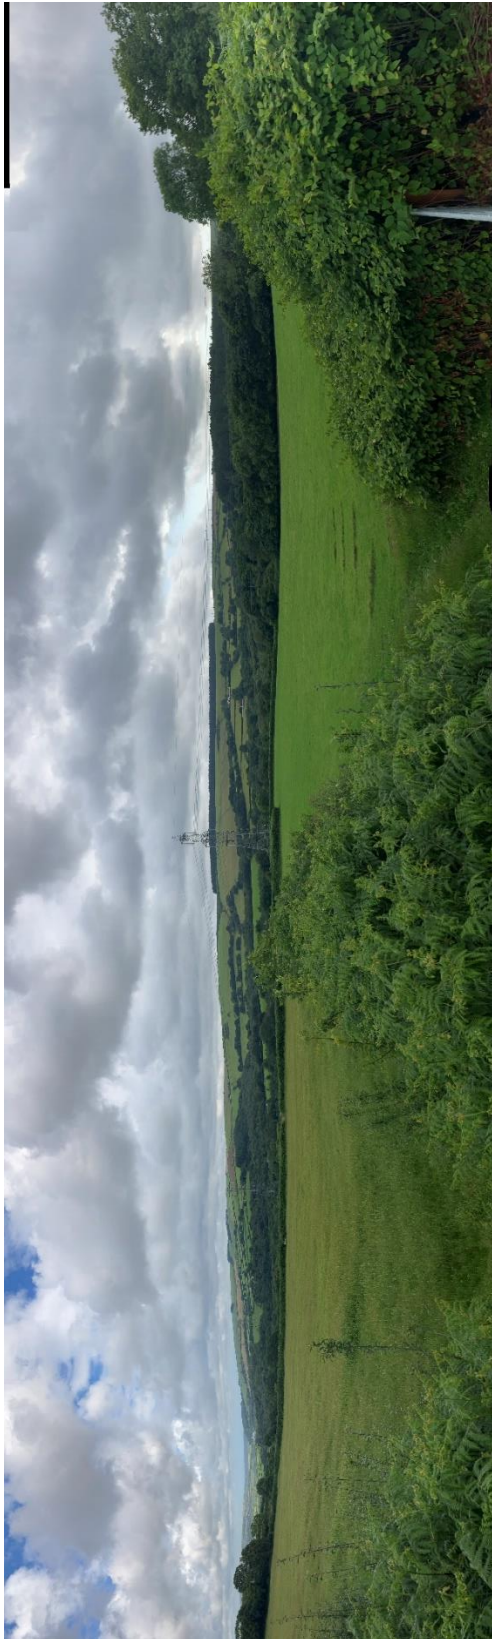
| <b>Photo No.</b><br><b>21</b> | <b>Date:</b><br><b>13.07.2023</b> | |

| Southerly view of area west to Adit 287185-001. | | |
| <b>Description:</b> Adit-001<br><br>Evidence of ground movements in land adjacent to Adit -001.<br>Unknown if associated with mining works or due to general slop stability. | | |

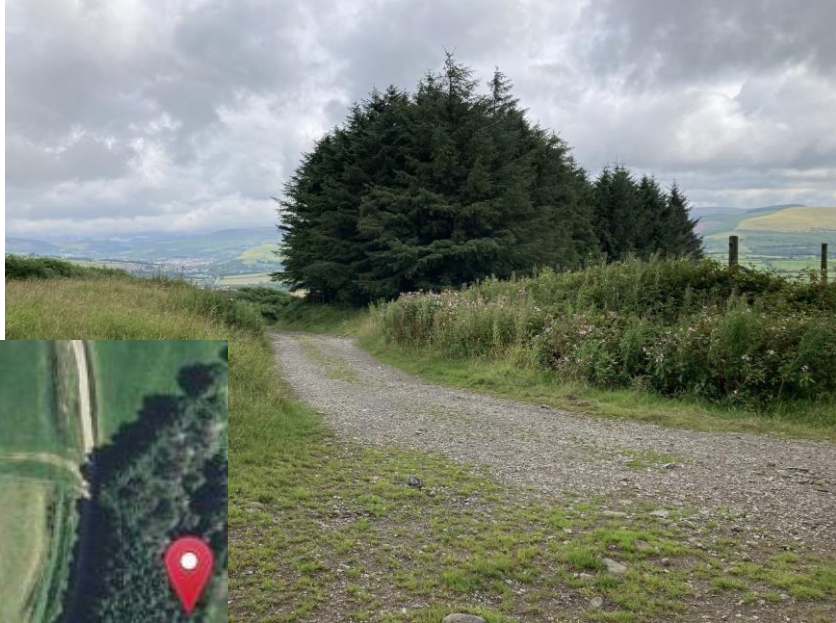
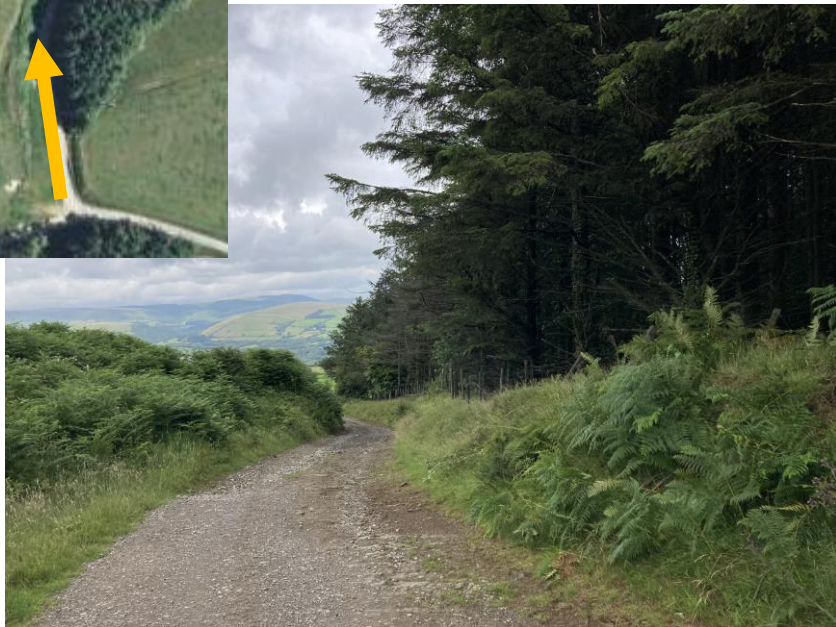
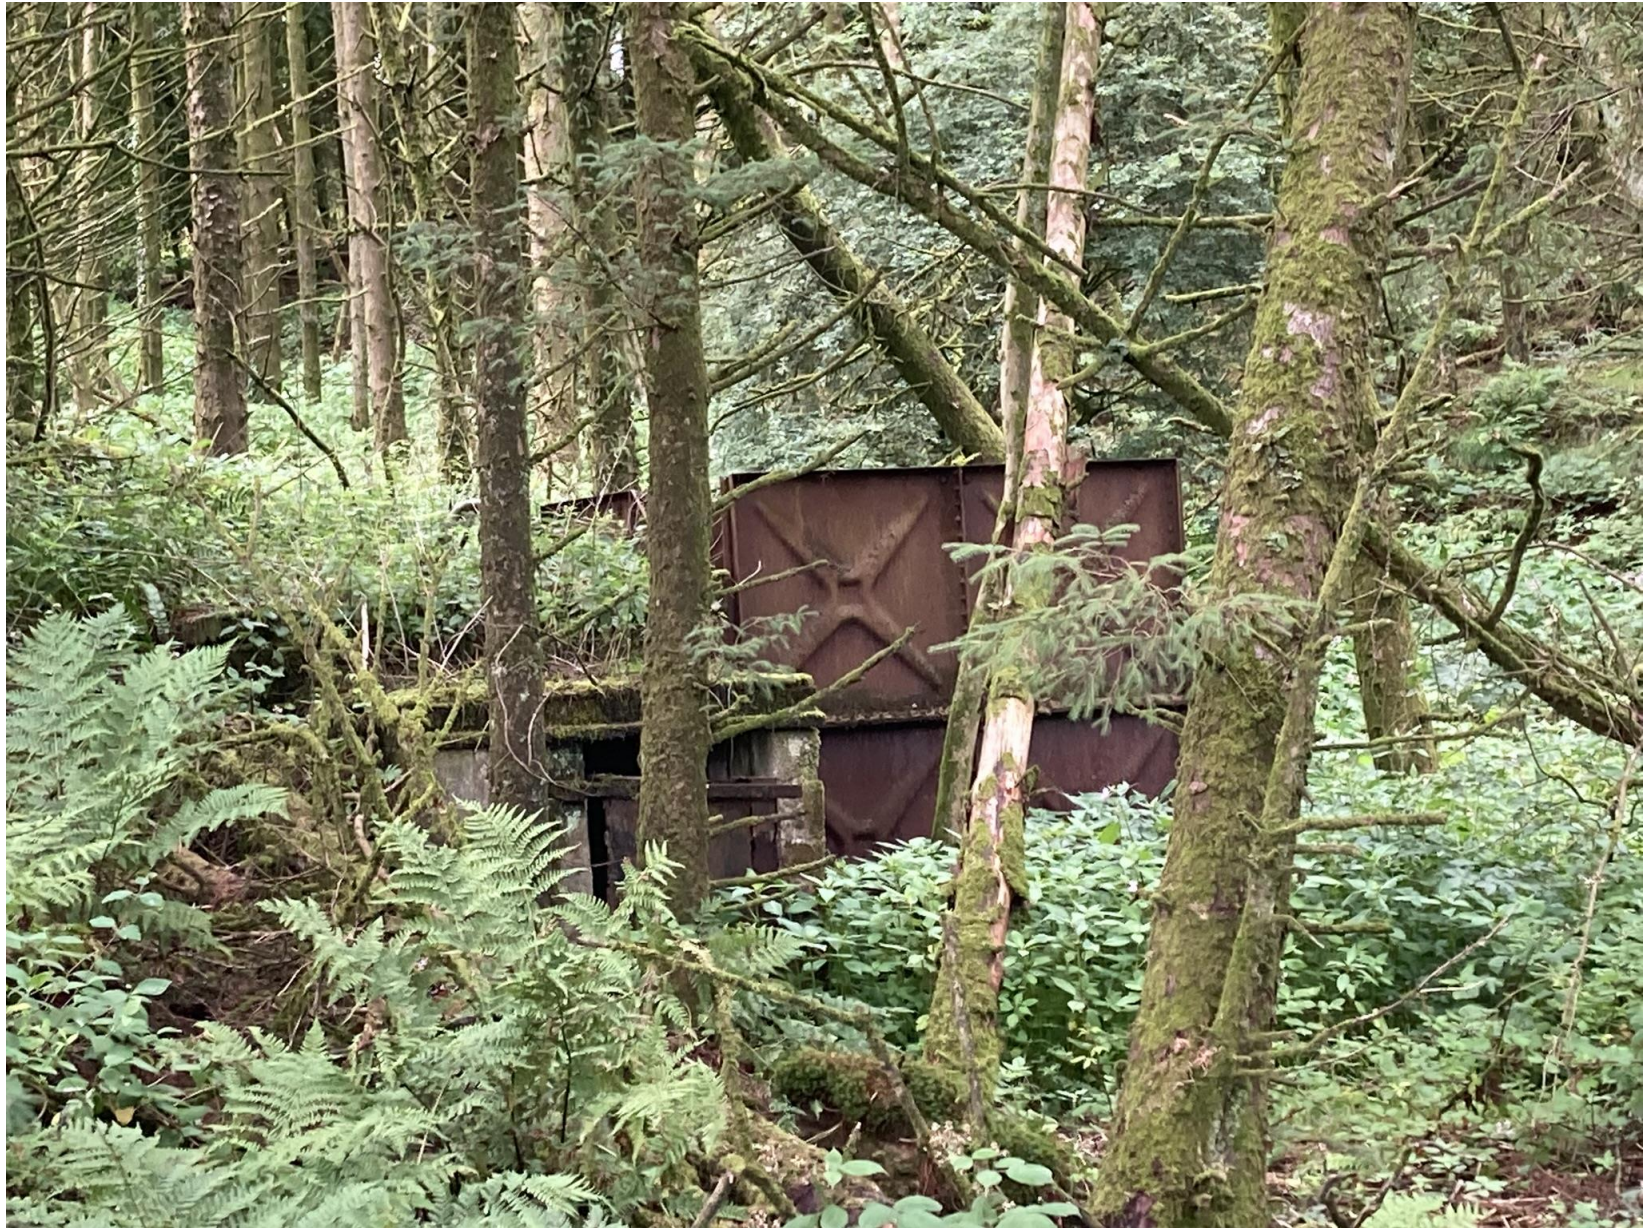
Audit -001

The two Adit were located in woodland surrounded by a fence with barbed wire. These areas could only be observed at the fence perimeter. However, a site entrance (and possible tank structure) could be seen within the vicinity of Adit -001. No associated mine structures were identified within the vicinity of Adit -002, due to dense woodland and the area sitting at a lower elevation.

Some evidence of slope erosion at some of the lowest parts of field boundaries. Some notable landslides (slumps) that may be associated with mining works around the two Adits.
