# Mynydd Ty-talwyn Energy Park – Environmental Statement Volume III

Appendix 5.2: Coal Mining Risk Assessment

Annex D – Adit Photographs

Project reference: 663870

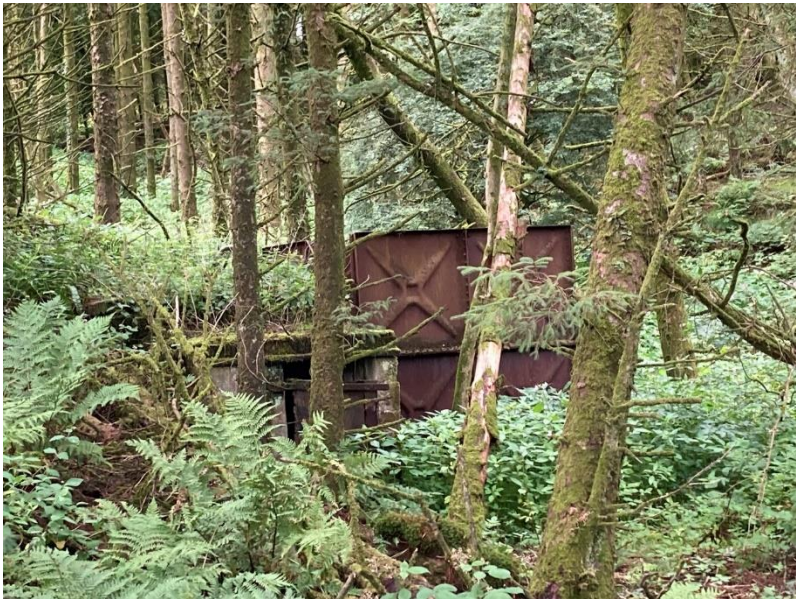
| <b>Photo No.</b><br><b>1</b> | <b>Date:</b><br><b>13.07.2023</b> | |

| South-westerly view into woodlands at the location of Adit 287185-001. | | |
| <b>Description:</b> Adit-001<br><br>View into wooded area, with possible Adit site entrance and tank structure. | | |

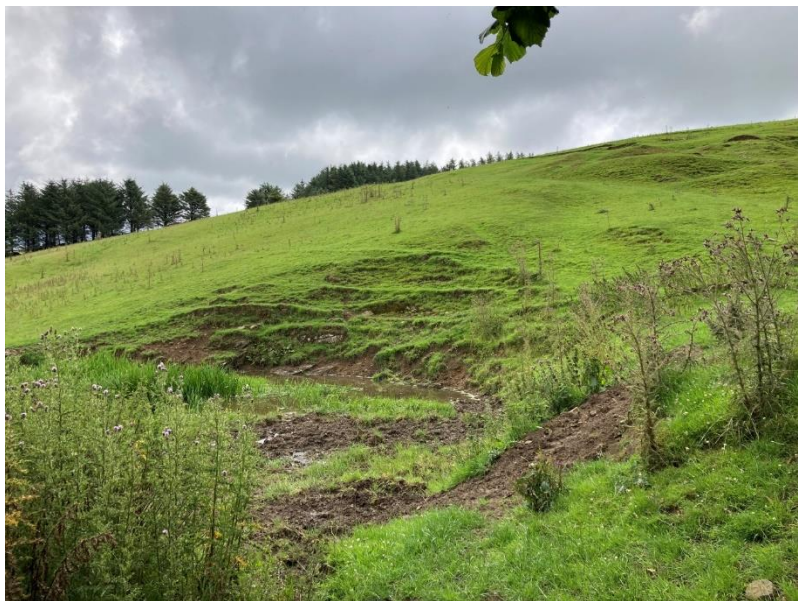
| <b>Photo No.</b><br><b>2</b> | <b>Date:</b><br><b>13.07.2023</b> | |

| Southerly view of area west to Adit 287185-001. | | |
| <b>Description:</b> Adit-001<br><br>Evidence of ground movements in land adjacent to Adit -001.<br>Unknown if associated with mining works or due to general slope stability. | | |

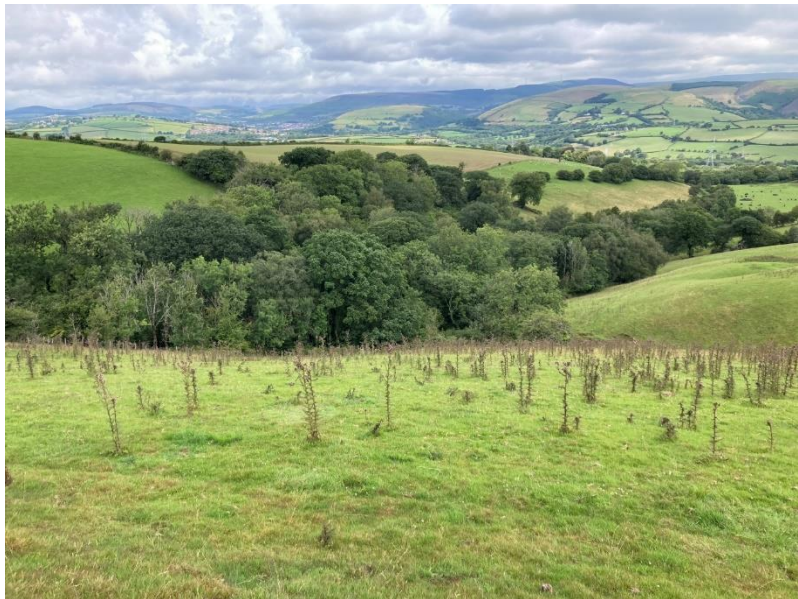
| <b>Photo No.</b><br>3 | <b>Date:</b><br>13.07.2023 | |

| Northerly view into woodlands at the location of Adit 287185-002. | | |
| <b>Description:</b> Adit-002<br><br>Woodland sitting at low elevation, in approximate direction of Adit 287185-002 (based on GPS co-ordinates). | | |

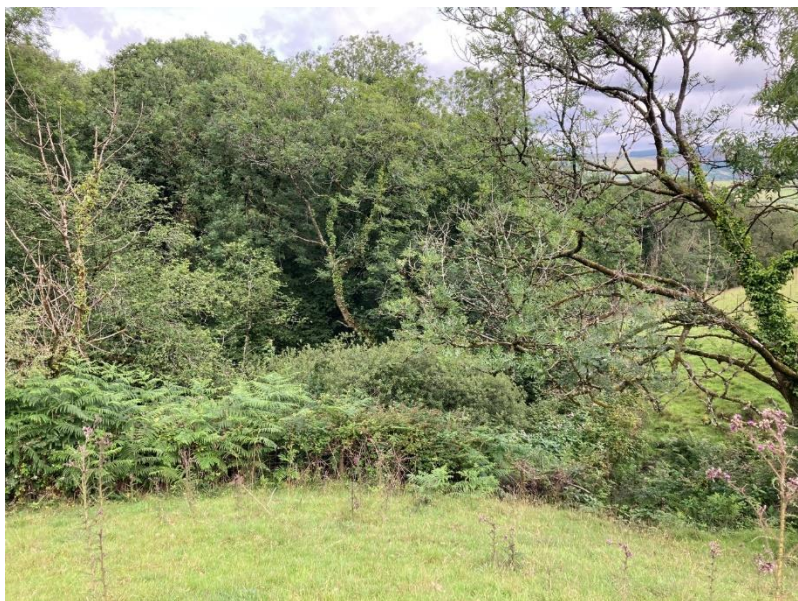
| <b>Photo No.</b><br><br>4 | <b>Date:</b><br>13.07.2023 | |

| Northerly view into woodlands at the location of Adit 287185-002. | | |
| <b>Description:</b> Adit-002<br><br>No associated mine structures were identified within the vicinity of Audit -002, due to dense woodland and the area sitting at a lower elevation. Wooded area fenced-off. | | |
