# Mynydd Ty-talwyn Energy Park - Environmental Statement Volume III

Appendix 6.1: Watercourse Crossing Baseline Assessment

Project Reference: 663870

Mynydd Ty-talwyn Energy Park

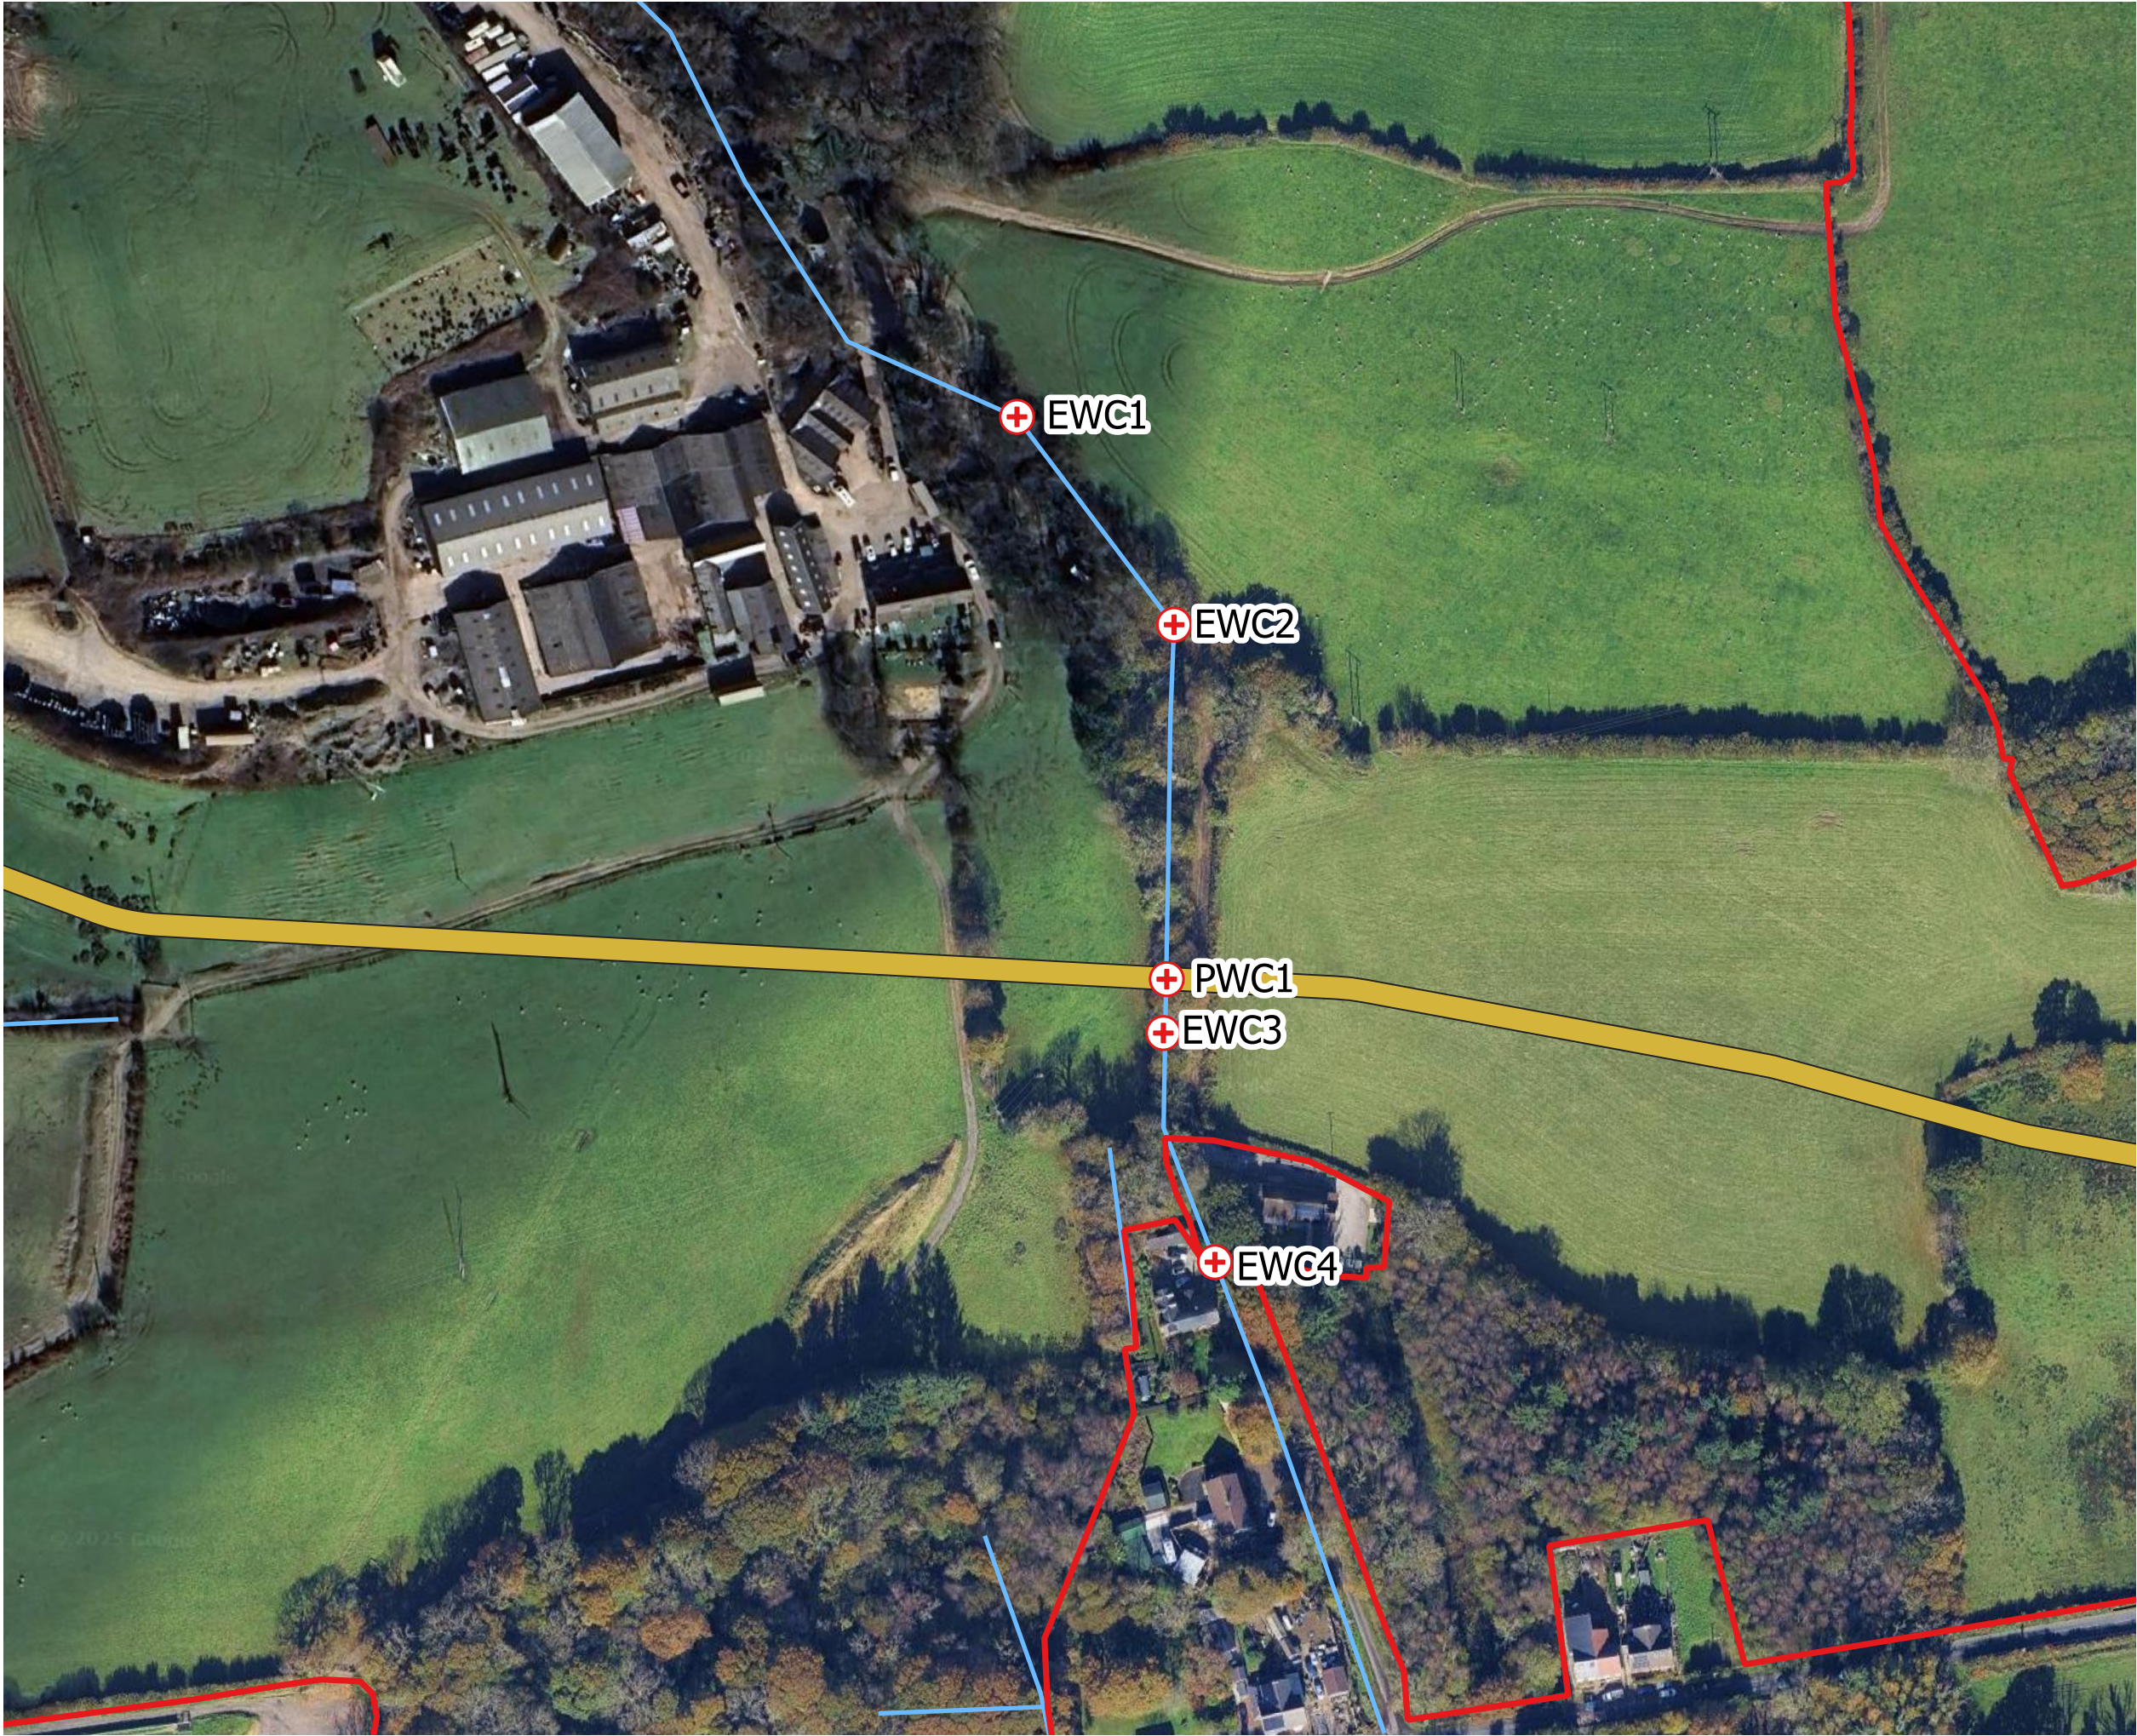
TITLE: Annex A  
Watercourse Crossing Locations  
(Nant Cwm-bach)

- A proposed crossing of an unnamed watercourse in the north-east of the Site, at Bryn-y-fro Farm (tributary of Afon Llynfi).
- 4.1.3 Four existing crossings were surveyed along Nant Cwm-bach, near to PWC1. These are shown in **Annex A** as EWC1, EWC2, EWC3 and EWC4.

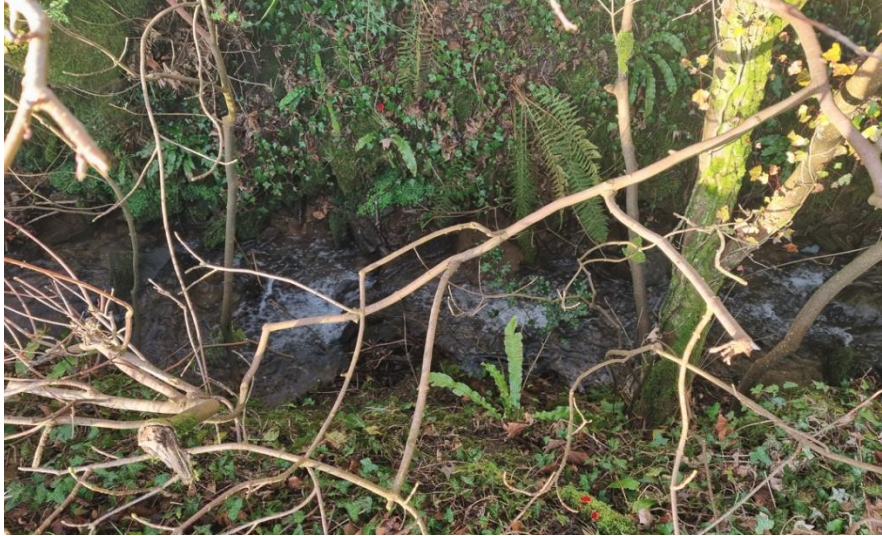
| <ul style="list-style-type: none"> <li>• Proposed crossing point over Nant Cwm-bach.</li> <li>• Located directly west of Cwm Risca Lane of which was noted to be steep.</li> <li>• Steep straight banks.</li> <li>• Fast flowing but shallow water.</li> <li>• Bed substrate comprised of larger rocks.</li> </ul> | | | |
| | | <p>Photo 1: Looking at the bed of the proposed crossing point taken from the left bank.</p> | |

- Could only be accessed from left bank.
- Trees comprised much of the top of banks for both left and right bank.
- Land drainage outfalls in the vicinity of the surveyed location, notably from the field to the east of Cwm Risca Lane.

| Watercourse Crossing | Top Width (m) | Depth (m) | Description | Likely Crossing Method* | Justification |
|---|---|---|---|---|---|
| PWC1 | 4.7 | 2.4 | Nant Cwm-bach Ordinary Watercourse | Bottomless Box/Arch | Narrow channel size. Limited potential hydraulic or ecological impact. |

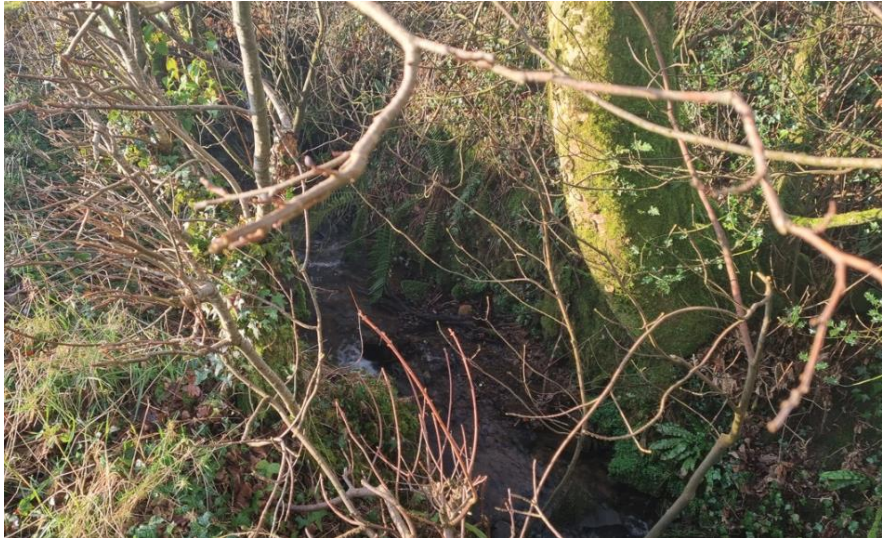
| | | <p>Photo 2: Looking downstream at the proposed crossing point, taken from the left bank.</p> | |

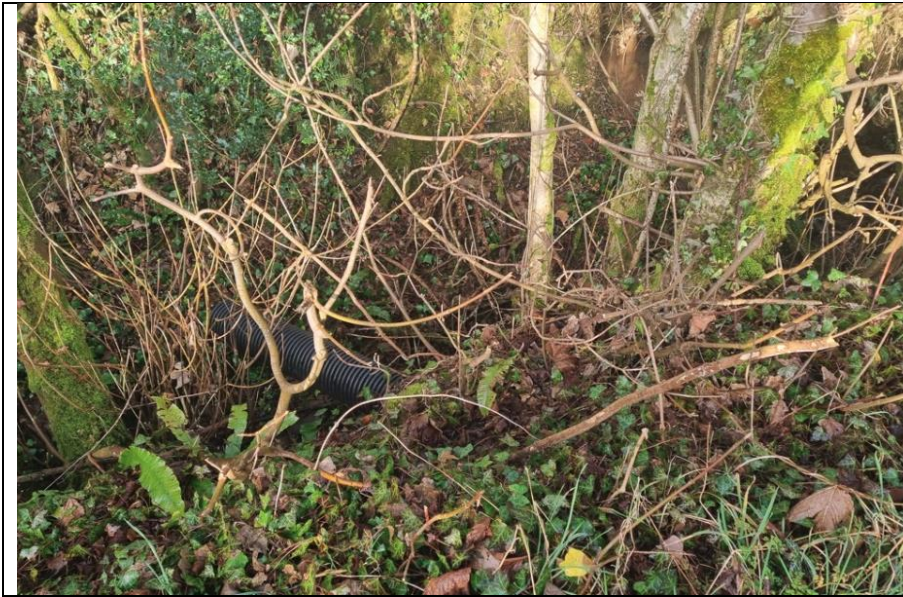
Photo 3: Pipe outfall assumed to be land drainage from the field to the east of Cwm Risca Lane.

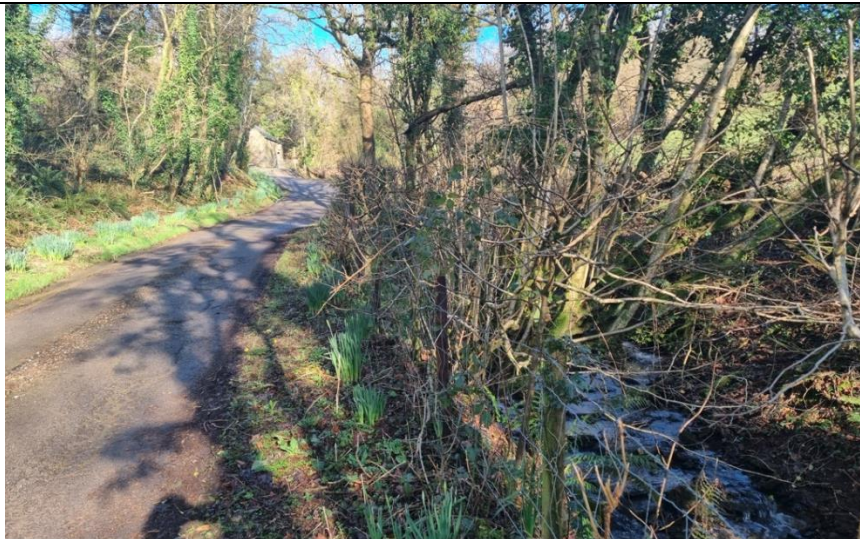
| <ul style="list-style-type: none"><li>Existing culvert crossing point over Nant Cwm-bach beneath Cwm Risca Lane and a lorry turning point.</li><li>Located directly east of Cwm Risca Lane.</li><li>Shallow beds.</li></ul> | | | |
| | | Photo 1: Looking upstream towards the culverted outfall. | |

- Vegetation obstructed the view of the outfall so it was unclear as to what crossing type this was.

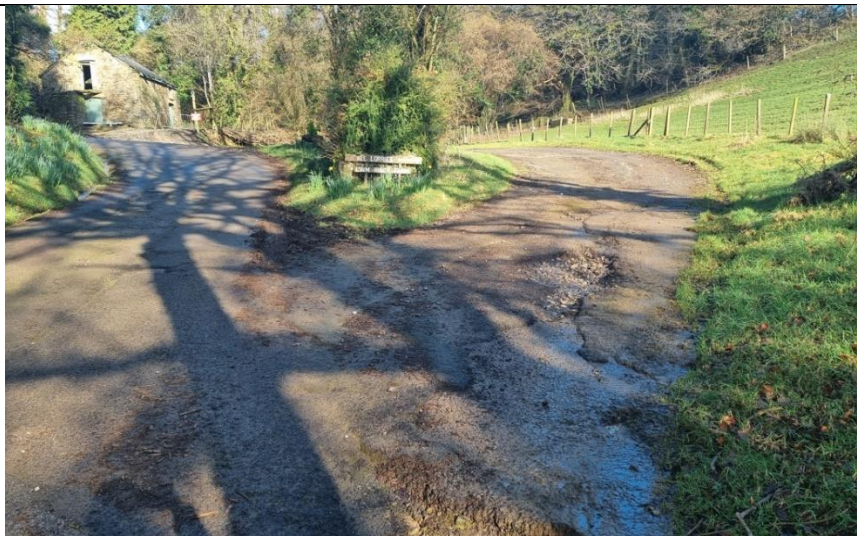
| | | Photo 2: Cwm Risca Lane and the lorry turning point which the crossing is assumed to be positioned beneath. | |
| <ul style="list-style-type: none"><li>Could not be accessed due to fencing (unable to be surveyed).</li></ul> | | | |

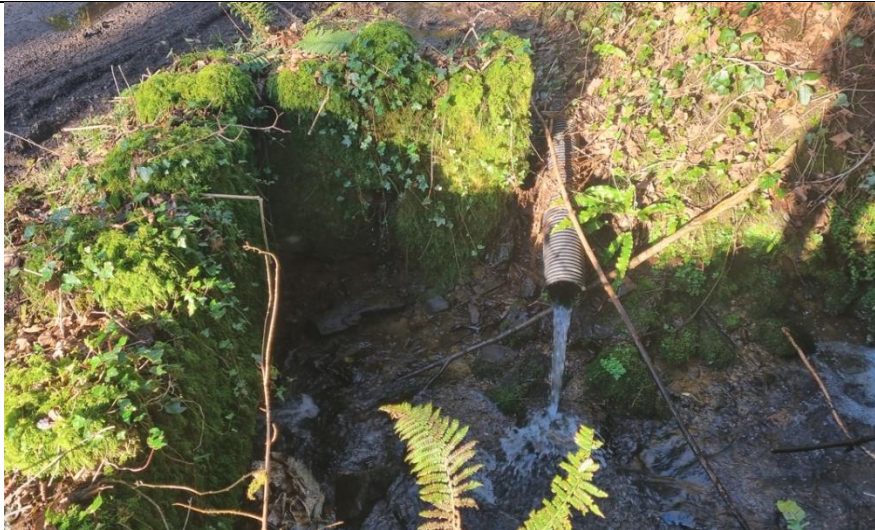
| <ul style="list-style-type: none"> <li>Existing culvert crossing point over Nant Cwm-bach beneath Cwm Risca Lane, directing the watercourse from the eastern side of the lane to the western side.</li> <li>Crossing consists of 2no. 250mm diameter circular culverts.</li> <li>Two drainage outfall pipes positioned to convey flow south-east discharge into the watercourse just before the crossing culvert inlets.</li> </ul> | | | | |
| | | | <p>Photo 1:<br/>Upstream culvert inlet location.<br/>Two small outfall pipes observed to be discharging to the watercourse at this location.</p> | |

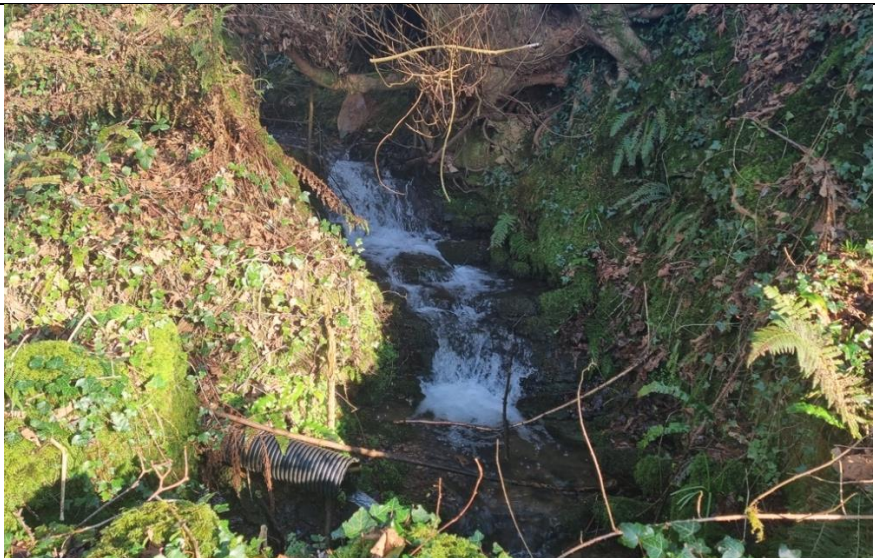
| | | | <p>Photo 2: Looking upstream from the crossing point.</p> | |

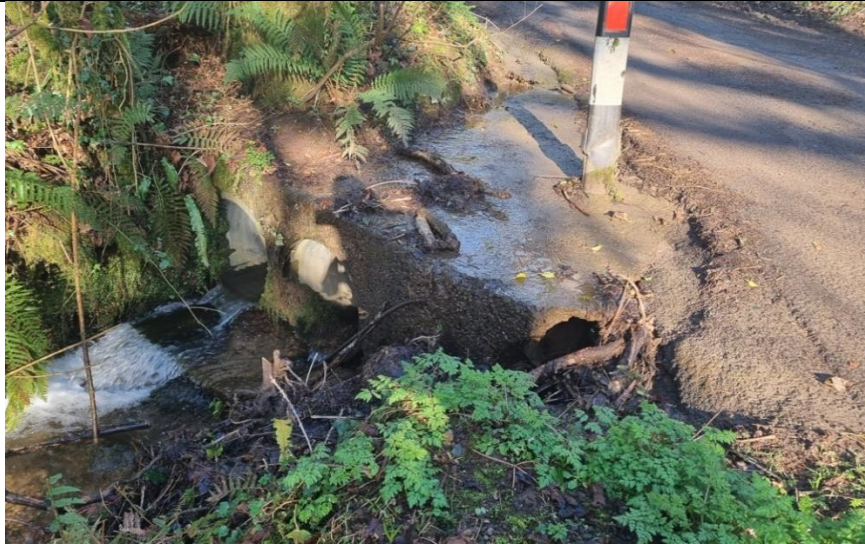
| | <p>Photo 3: A view of the downstream outlet of the double culverts.</p> |
| <ul style="list-style-type: none"> <li>• The road tarmac was observed to be damaged/eroded in the location above/adjacent to the downstream culvert outlet.</li> <li>• Surface water was observed along Cwm Risca Lane, entering the watercourse at the location of the culvert crossing outlet.</li> <li>• Culvert inlets observed to be partially blocked by leaf litter and tree branches.</li> </ul> | |

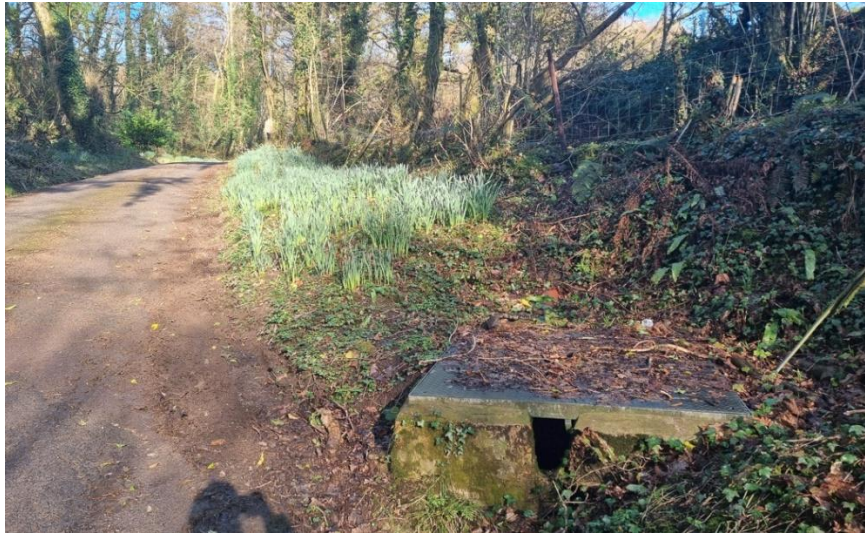
| | <p>Photo 4: A manhole located on the eastern side of Cwm Risca Lane. Its positioning suggests it's potentially linked to the outfall pipes discharging to the upstream extent of the crossing.</p> |

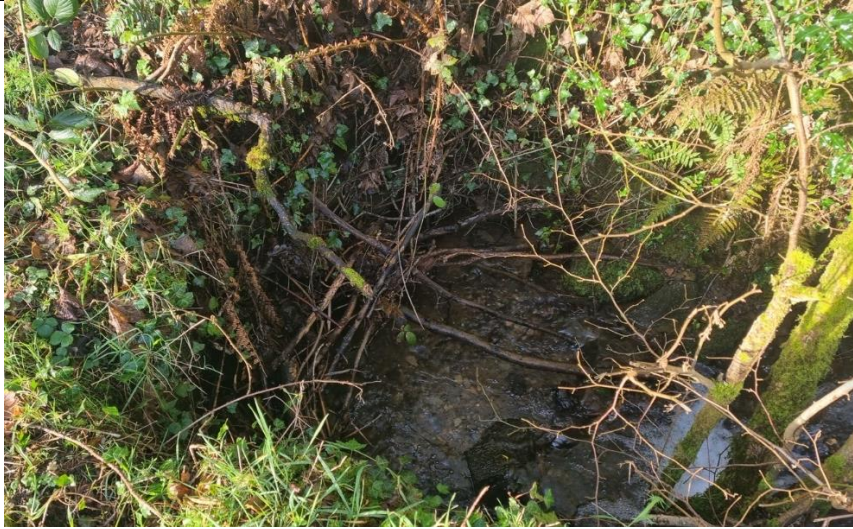
| <ul style="list-style-type: none"> <li>Existing culverted field access of Nant Cwm-bach.</li> <li>Crossing consists of 1no. 300mm diameter circular culvert.</li> <li>Water flowed fast and shallow through the culvert.</li> <li>Large rocks were observed as the bed substrate.</li> <li>The left bank was observed to be very shallow with both banks being straight.</li> </ul> | | | |
| | | <p>Photo 1: Upstream culvert inlet of crossing point.</p> | |

| <ul style="list-style-type: none"> <li>• The upstream extent of the culvert was partially blocked by bracken and branches.</li> </ul> | |

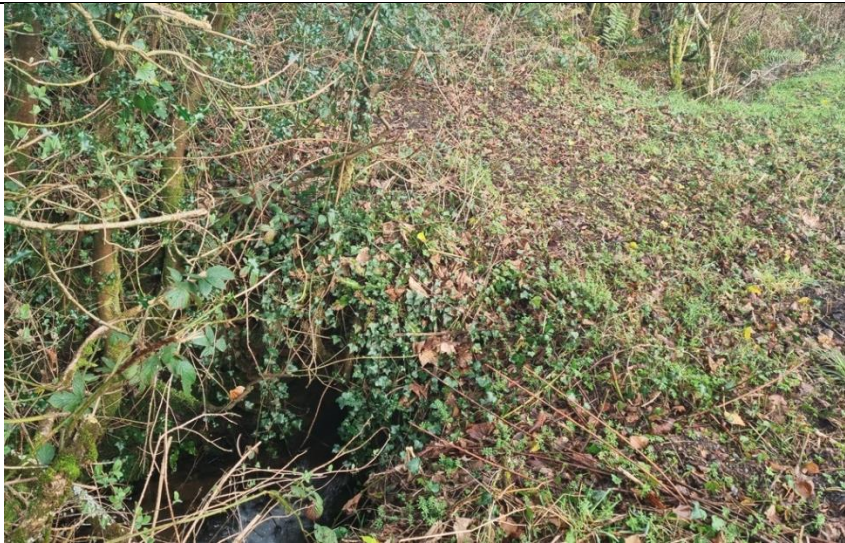
| | | <p>Photo 2: Downstream culvert outlet of crossing point.</p> | |

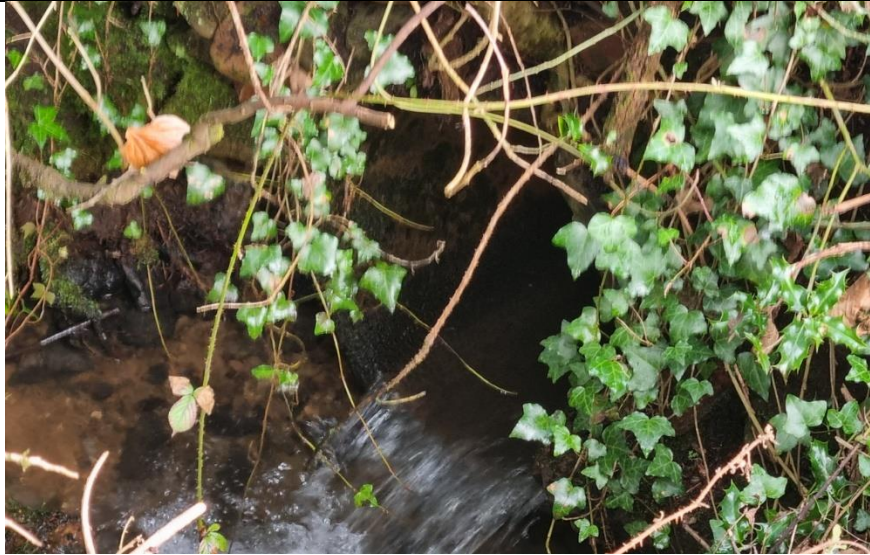
| | <p>Photo 3: Closer view of the downstream culvert outlet.</p> |

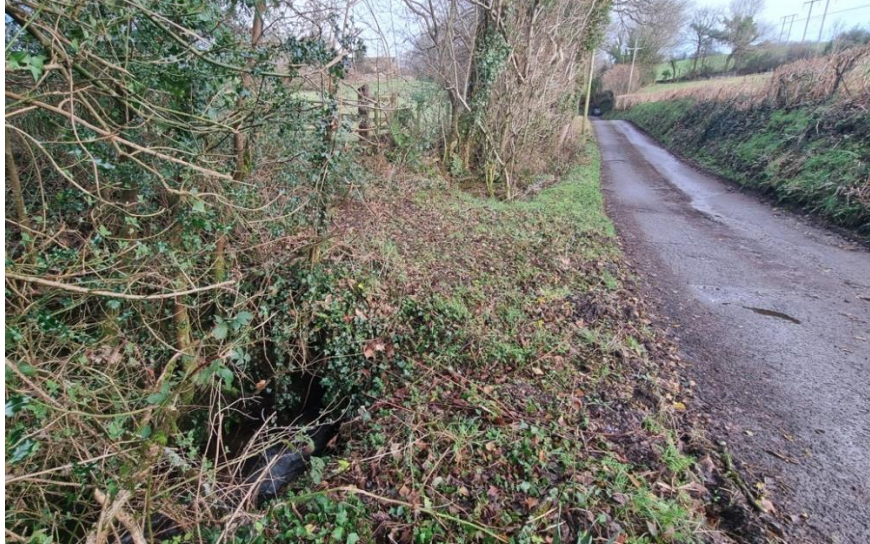
| | <p>Photo 4: Wider view of the existing field access crossing (looking from the downstream extent).</p> |

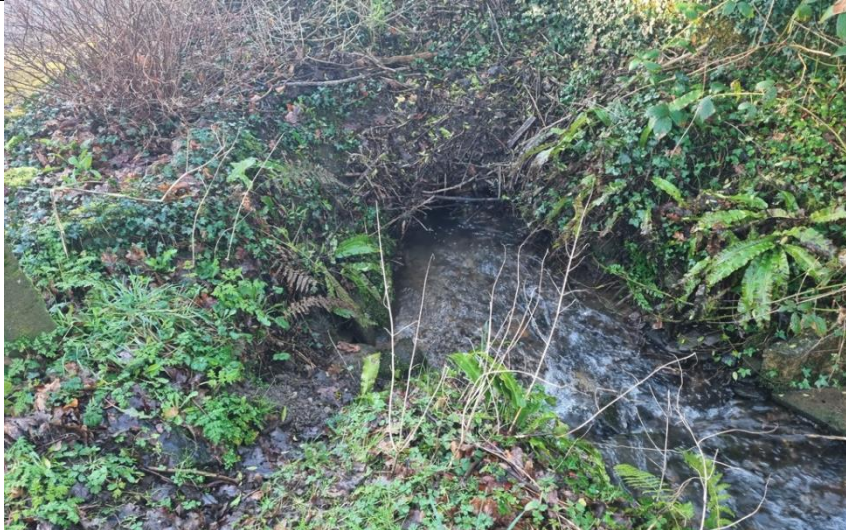
| <ul style="list-style-type: none"> <li>Existing culverted driveway access of Nant Cwm-bach for the property opposite Swn y Nant.</li> <li>Crossing consists of 1 no. 300mm diameter circular culvert.</li> <li>Water flowed fast and shallow through the culvert.</li> <li>Large, slabbed rocks were observed as the bed substrate of the downstream extent.</li> <li>A boundary wall makes up the right bank of the watercourse with multiple outfall pipes on the downstream side discharging into the watercourse.</li> </ul> | | | |
| | | <p>Photo 1: Upstream culvert inlet of crossing point.</p> | |

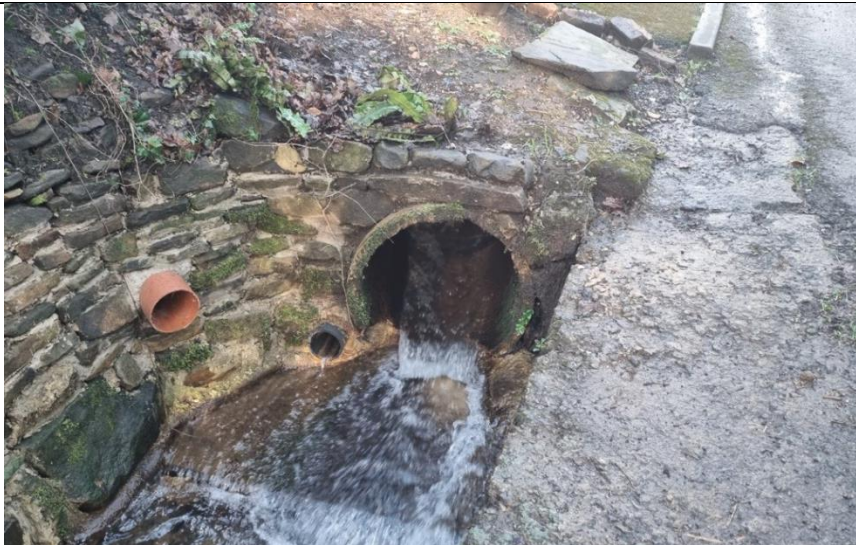
| | | <p>Photo 2:<br/>Downstream culvert outlet of crossing point.</p> | |

- The owners of the property noted that during times of heavy rainfall, the culvert was approximately half full.
- The owners of the property noted that surface water runoff along Cwm Risca Lane enters into the watercourse at the downstream culvert outlet and forms a whirlpool within this area.

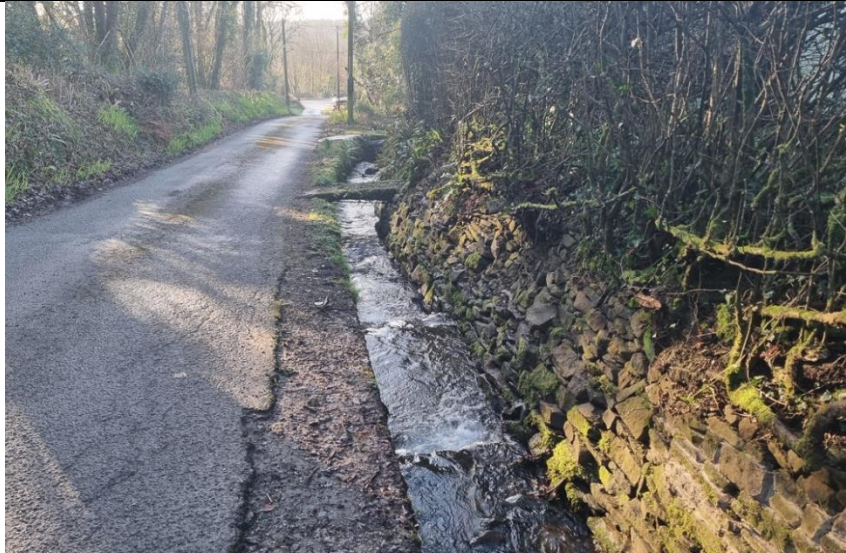
Photo 3: A view of the downstream extent of the watercourse from the location of the outlet.

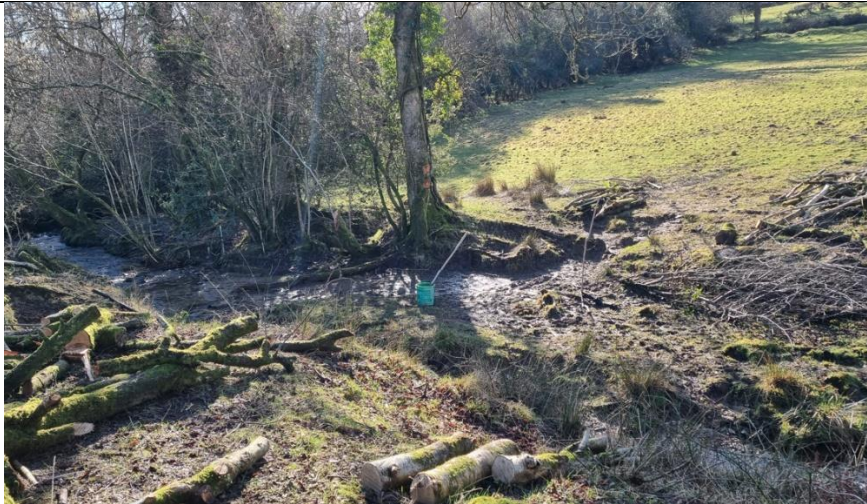
| <ul style="list-style-type: none"> <li>Proposed crossing point over the unnamed Ordinary Watercourse.</li> <li>The left bank was steep and straight.</li> <li>The right bank was not defined and comprised the field to the west of the watercourse which had a gradual fall, creating a wider floodplain.</li> <li>Fast flowing water.</li> <li>Bed substrate comprised of a mix of larger and smaller pebbles and sand sediments.</li> </ul> | | | |
| | | <p>Photo 1: Looking downstream across the proposed crossing point from the left bank.</p> | |

| <ul style="list-style-type: none"> <li>• The width of the watercourse was measured from the top of the left bank to the same elevation on the right bank.</li> <li>• The sand sediments on right-hand side of the bed indicated that the channel becomes wider during higher intensity rainfall events.</li> </ul> | |

| Watercourse Crossing | Top Width (m) | Depth (m) | Description | Likely Crossing Method* | Justification |
|---|---|---|---|---|---|
| PWC2 | 18.0 | 0.7 | Unnamed Ordinary watercourse at Bryn-y-fro Farm | Single/Clear-span Bridge or Bottomless Box/Arch | Wide, shallow right bank with the watercourse channel not as defined. Minimise disturbance to bed and banks. |

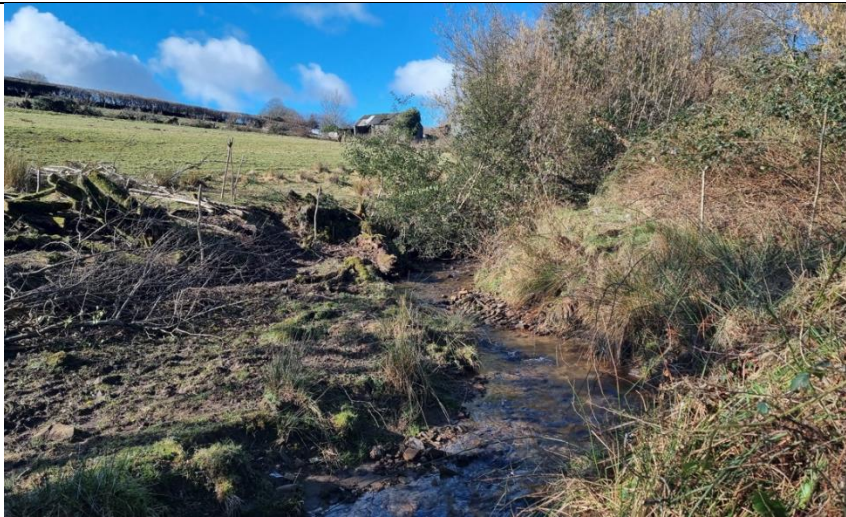
| | | <p>Photo 2: Looking upstream at the proposed crossing point.</p> | |

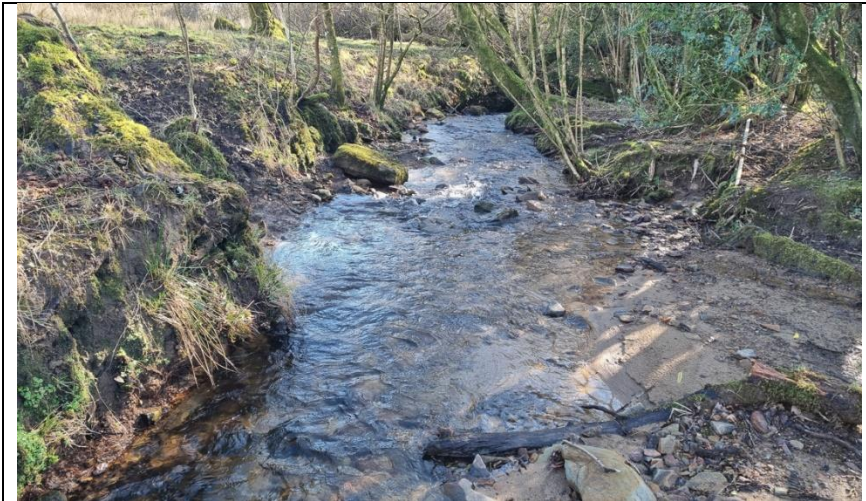
| | <p>Photo 3: Looking downstream at the proposed crossing point. Sandy sediments were observed on the right of the channel.</p> |

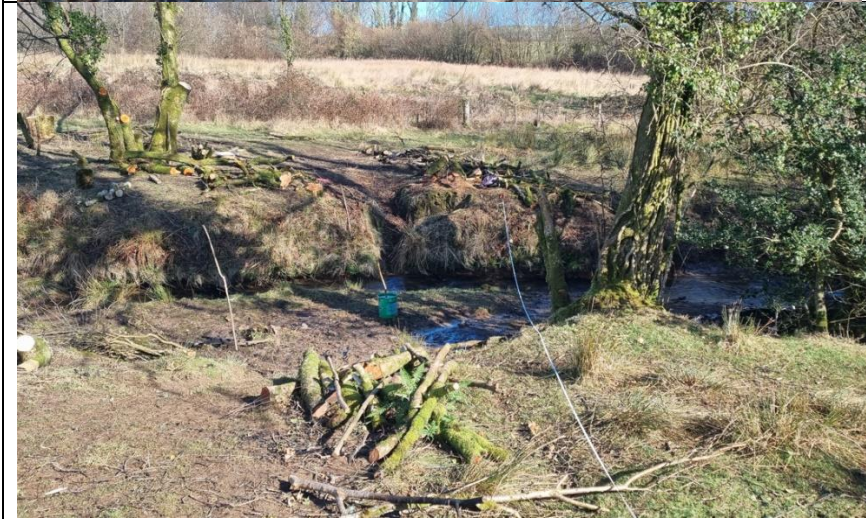
| | <p>Photo 4: A view across the proposed crossing point taken from the right bank.</p> |

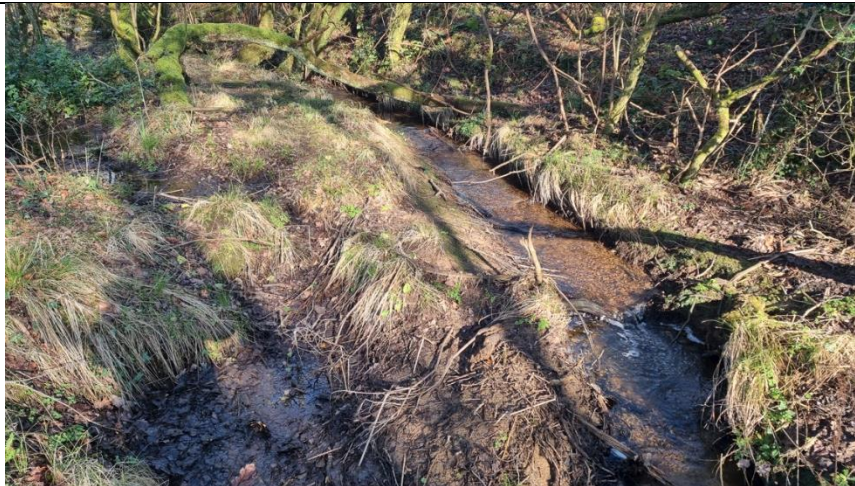
| <ul style="list-style-type: none"> <li>Existing road crossing point beneath an unnamed Ordinary watercourse at Bryn Fo Farm.</li> <li>The crossing comprised 1no. 200mm diameter circular culvert.</li> <li>The bed became very wide in the location of the upstream culvert inlet with the width further upstream being significantly narrower.</li> <li>Bed substrate comprised of sandy, fine pebbles in the upstream extent with more coarse material downstream.</li> </ul> | | | | |
| | | | Photo 1: Looking upstream from the culvert inlet. | |

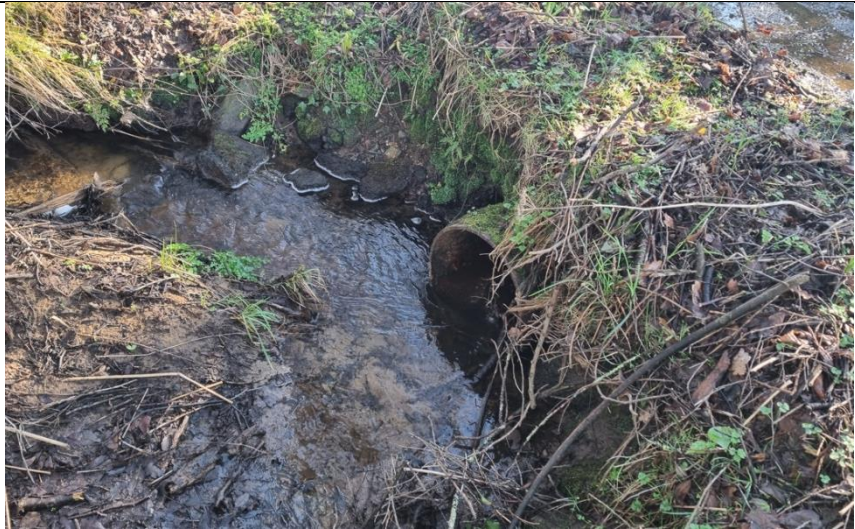
| | | | Photo 2: A view of the upstream culvert inlet as the bed becomes wider. | |

- A dry ephemeral watercourse was observed to connect to the upstream extent of the watercourse.

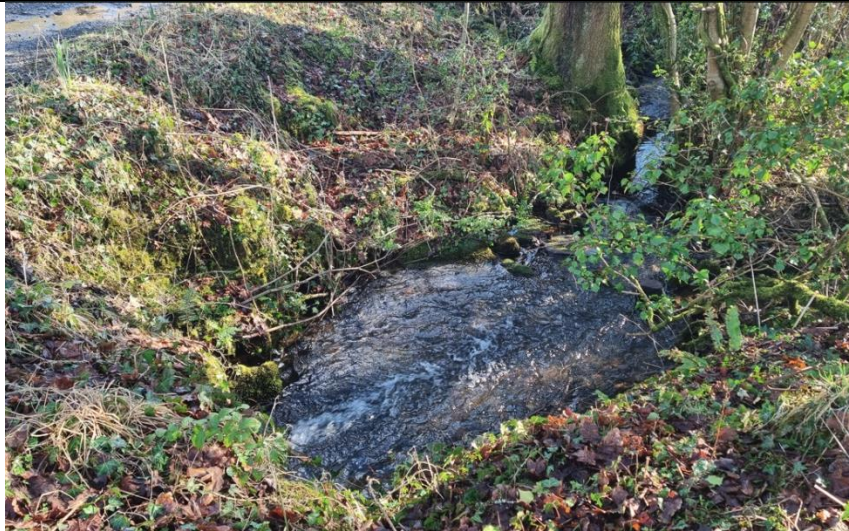
Photo 3: A downstream view from the culvert outlet.

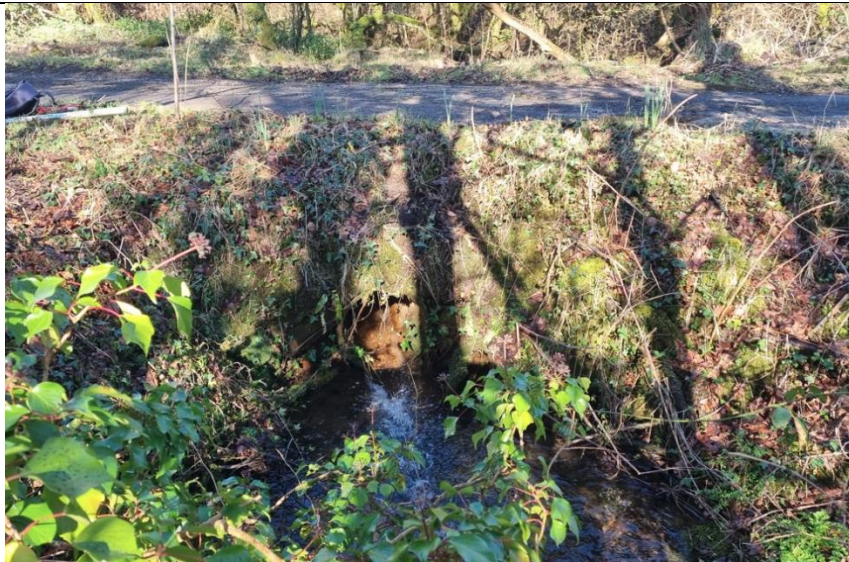
Photo 4: A view of the downstream culvert outlet, looking upstream.
