# Mynydd Ty-talwyn Energy Park – Environmental Statement Volume III

Appendix 5.1: Preliminary Risk Assessment

Annex C – Site Reconnaissance Information

Project reference: 663870

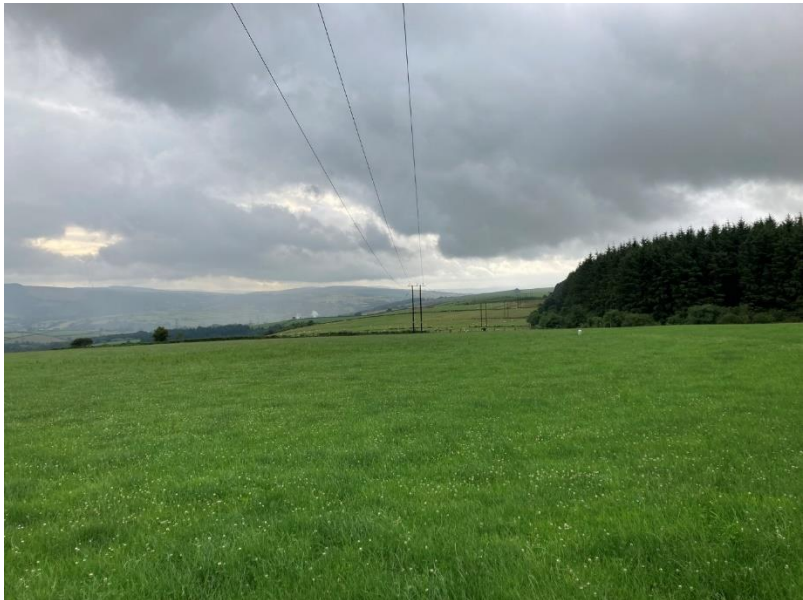
| Easterly view along northern site boundary | | |
| <b>Description:</b><br><br>Fields used mainly for pasture with some blocks of woodland.<br>Woodland located in right of photograph is Craig Yr Aber (Wooded country park).<br><br>Overhead electrical cables and underground gas route run along C-Class Road and continue along the Ogwr Ridgeway. | | |

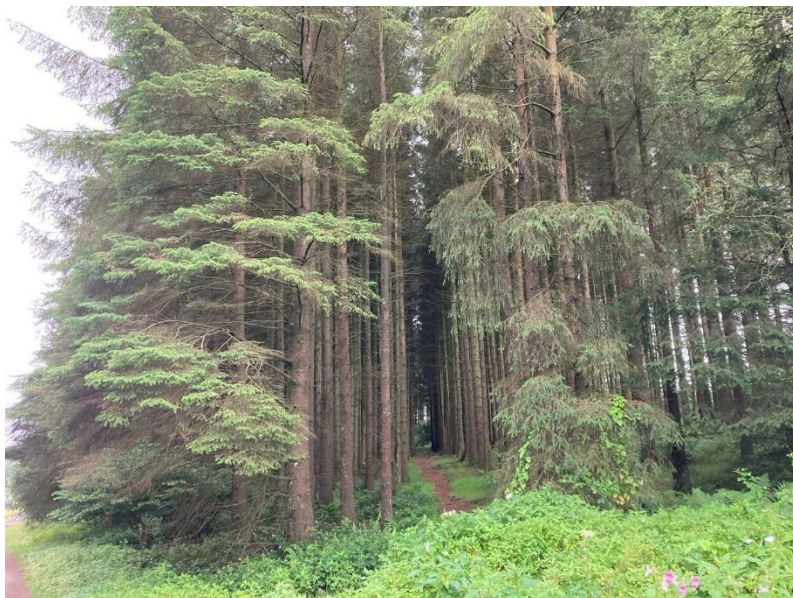
| <b>Photo No.</b><br><b>3</b> | <b>Date:</b><br><b>13.07.2023</b> | |

| South-easterly view in<br>Craig yr Aber (Wooded<br>country park) | | |
| <b>Description:</b><br><br>Craig yr Aber (Wooded country<br>park) within sites western<br>boundary. | | |

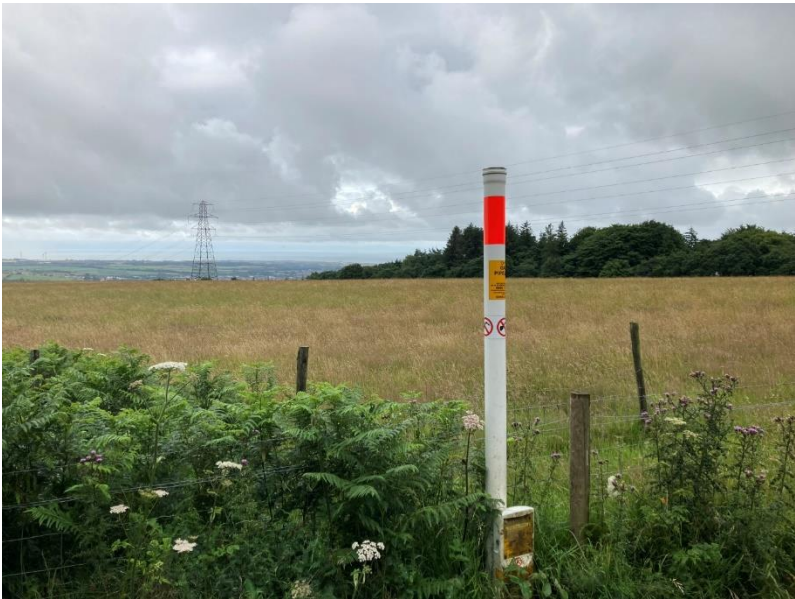
| <b>Photo No.</b><br><br>4 | <b>Date:</b><br>13.07.2023 | |

| South-westerly view<br>across field with indicative<br>Turbine #8 location | | |
| <b>Description:</b> Turbine #8<br><br>Open field with power cables and<br>gas main running across site. (Gas<br>main route unknown). Area<br>relatively level, dipping gently<br>south. | | |

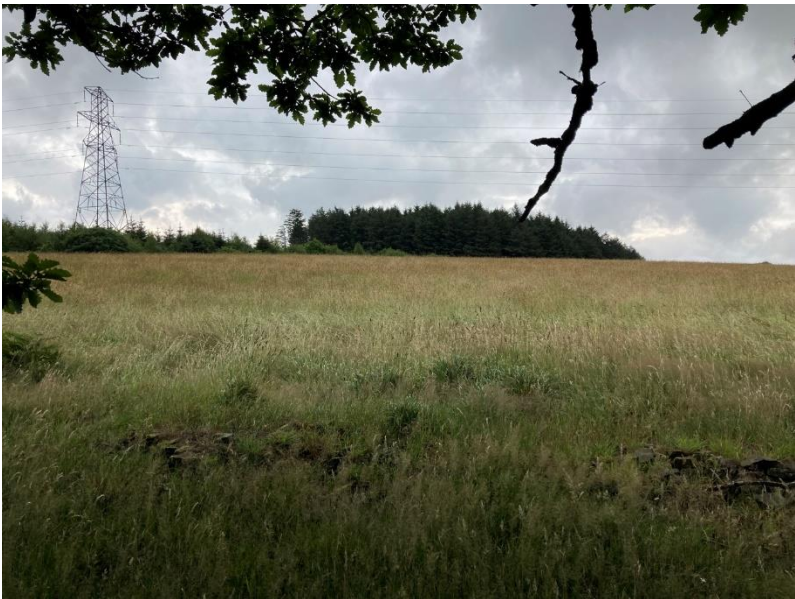
| <b>Photo No.</b><br>5 | <b>Date:</b><br>13.07.2023 | |

| Westerly view across field with indicative Turbine #8 location | | |
| <b>Description:</b> Turbine #8<br><br>Open field with power cables running across site. Craig yr Aber (Wooded country park) in distance. Area relatively level, dipping gently south. | | |

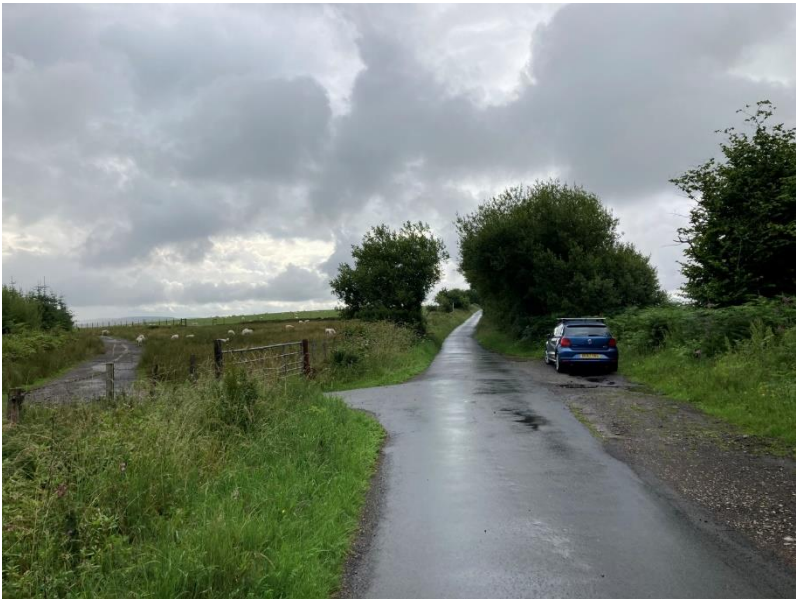
| <b>Photo No.</b><br>6 | <b>Date:</b><br>13.07.2023 | |

| Easterly view towards<br>indicative Turbine #7<br>location | | |
| <b>Description:</b> Turbine #7<br><br>Road junction before indicative<br>field location of Turbine #7. Fields<br>used mainly for pasture with some<br>blocks of woodland. Gas main<br>location runs along road. Area<br>relatively level. | | |

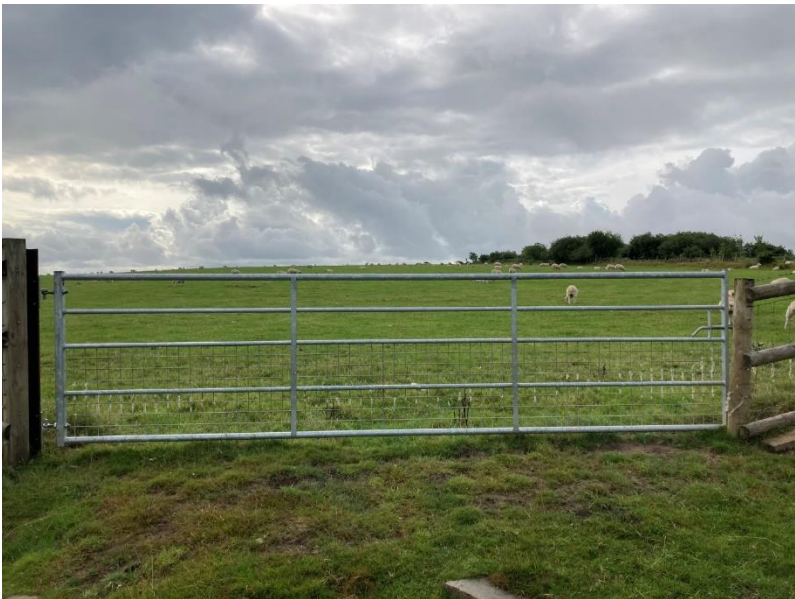
| <b>Photo No.</b><br>7 | <b>Date:</b><br>13.07.2023 | |

| North-easterly view across field with indicative Turbine #7 location | | |
| <b>Description:</b> Turbine #7<br>Fields used mainly for pasture.<br>Area relatively level. | | |

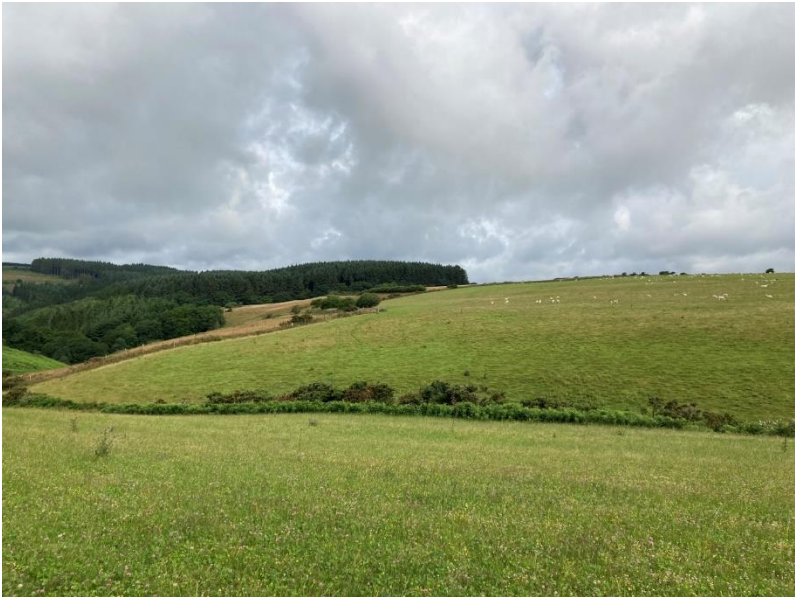
| <b>Photo No.</b><br>8 | <b>Date:</b><br>13.07.2023 | |

| North-westerly view across open field, then view across field with indicative Turbine #6 location | | |
| <b>Description:</b> Turbine #6<br>Fields used mainly for pasture. Indicative Turbine #6 field location raises up towards the north. Craig yr Aber (Wooded country park) located towards the west. | | |

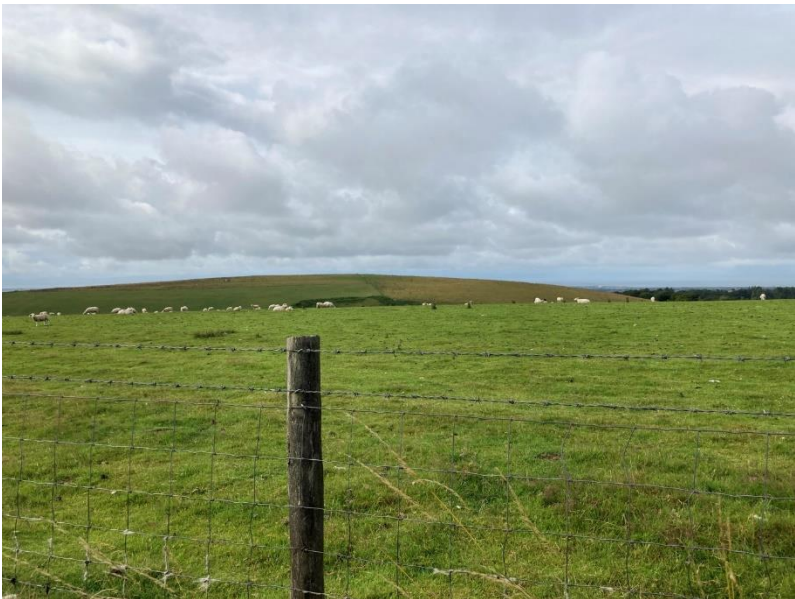
| <b>Photo No.</b><br><b>9</b> | <b>Date:</b><br><b>13.07.2023</b> | |

| Southerly view across field with indicative Turbine #6 location (Turbine #5 location in distance). | | |
| <b>Description:</b> Turbine #6<br>Fields used mainly for pasture.<br>Field dips down towards the south. | | |

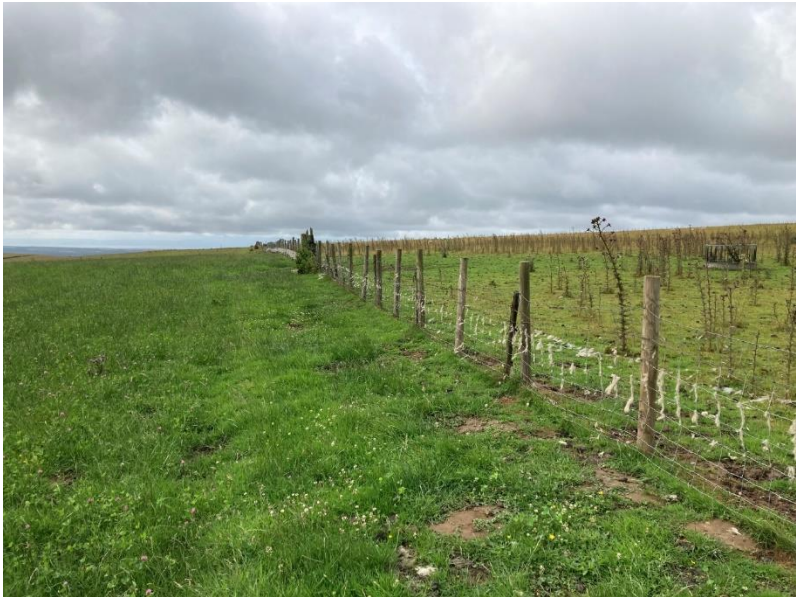
| <b>Photo No.</b><br><b>10</b> | <b>Date:</b><br><b>13.07.2023</b> | |

| Southerly view along field boundary. Indicative Turbine #5 location is in the field on the right (west). | | |
| <b>Description:</b> Turbine #5<br><br>Fields used mainly for pasture.<br>Area relatively level and split with field boundaries. | | |

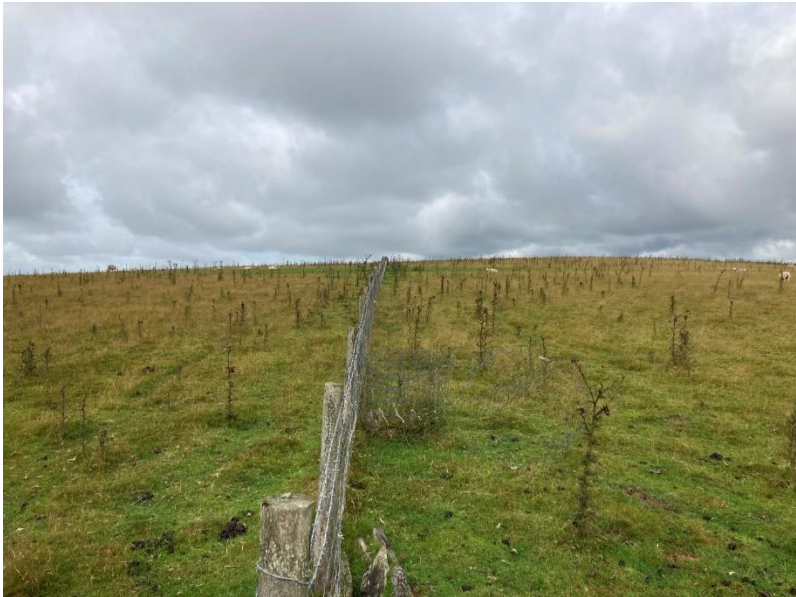
| <b>Photo No.</b><br><b>11</b> | <b>Date:</b><br><b>13.07.2023</b> | |

| Westerly view along field boundary for indicative Turbine #5 location | | |
| <b>Description:</b> Turbine #5<br><br>Fields used mainly for pasture.<br>Area relatively level and split with field boundaries. | | |

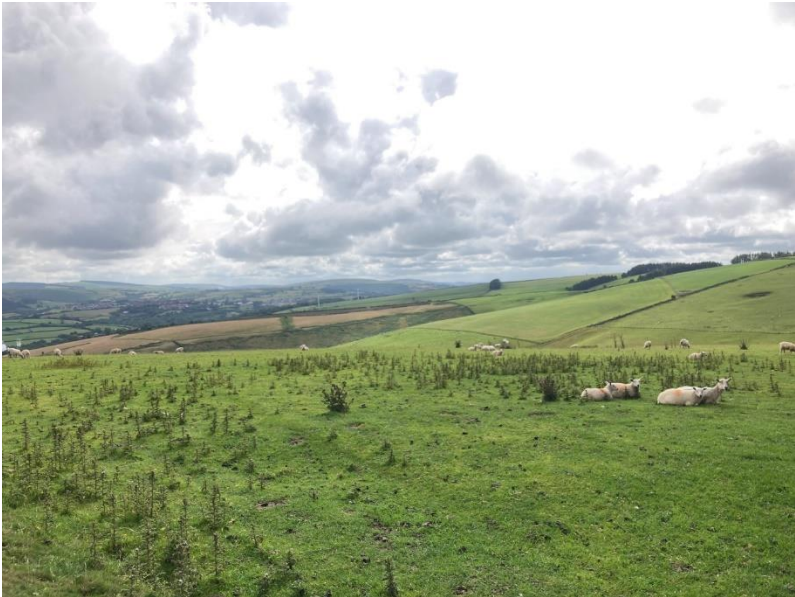
| <b>Photo No.</b><br><br>12 | <b>Date:</b><br><b>13.07.2023</b> | |

| North-easterly view across field with indicative Turbine #4 location | | |
| <b>Description:</b> Turbine #4<br><br>Fields used for pasture. Area dips down towards the north. | | |

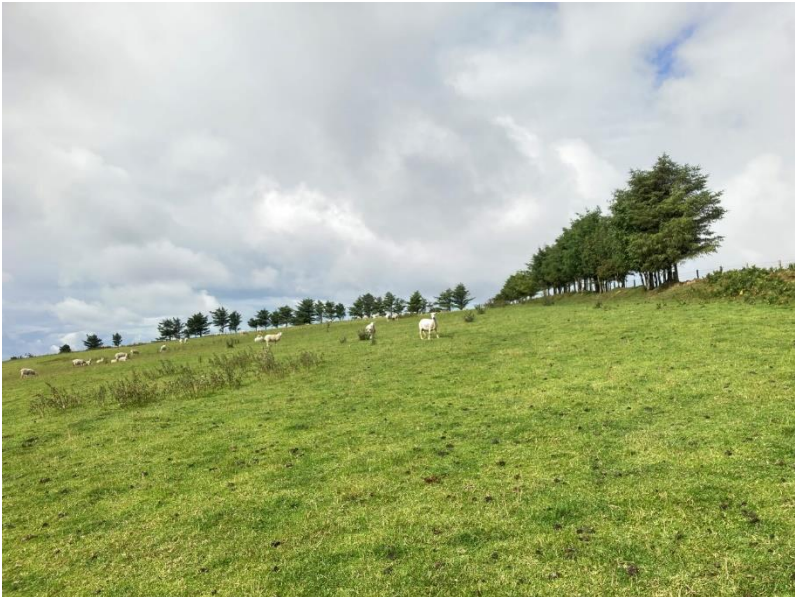
| <b>Photo No.</b><br><b>13</b> | <b>Date:</b><br><b>13.07.2023</b> | |

| View towards south-western corner of field for indicative Turbine #4 location | | |
| <b>Description:</b> Turbine #4<br><br>Fields used for pasture. Some trees line the south-western corner of site. Area rises towards the south. | | |

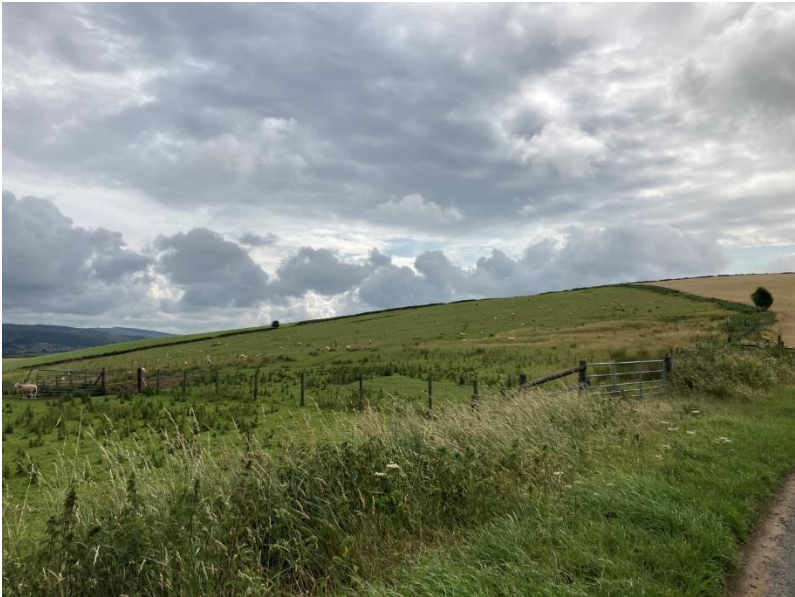
| <b>Photo No.</b><br><br>14 | <b>Date:</b><br><b>13.07.2023</b> | |

| Easterly view across field with indicative Turbine #3 location | | |
| <b>Description:</b> Turbine #3<br><br>Fields used for pasture. Area rises towards the east. Southern boundary of field follows the C-Class Road and Ogwr Ridgeway walking route. | | |

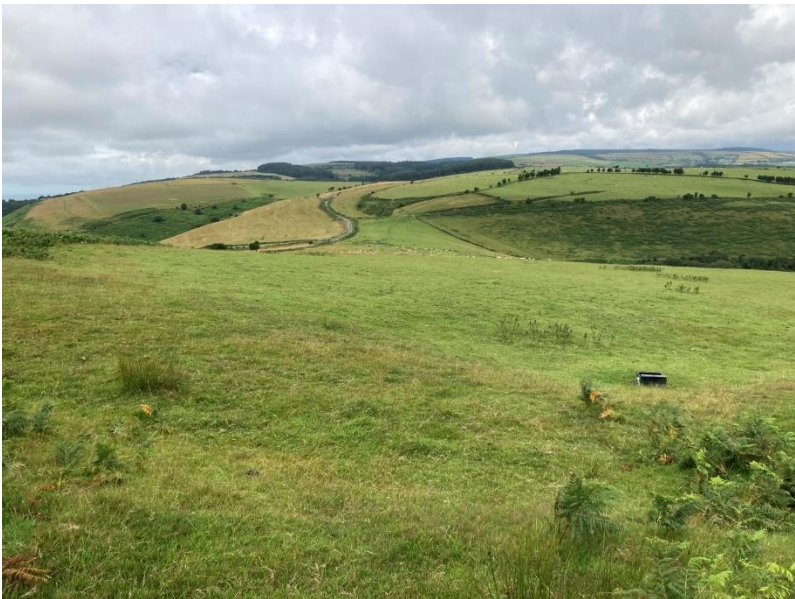
| <b>Photo No.</b><br><b>15</b> | <b>Date:</b><br><b>13.07.2023</b> | |

| Westerly view across field with indicative Turbine #3 location | | |
| <b>Description:</b> Turbine #3<br><br>Fields used for pasture. Area dips down towards the west and undulates slightly. | | |

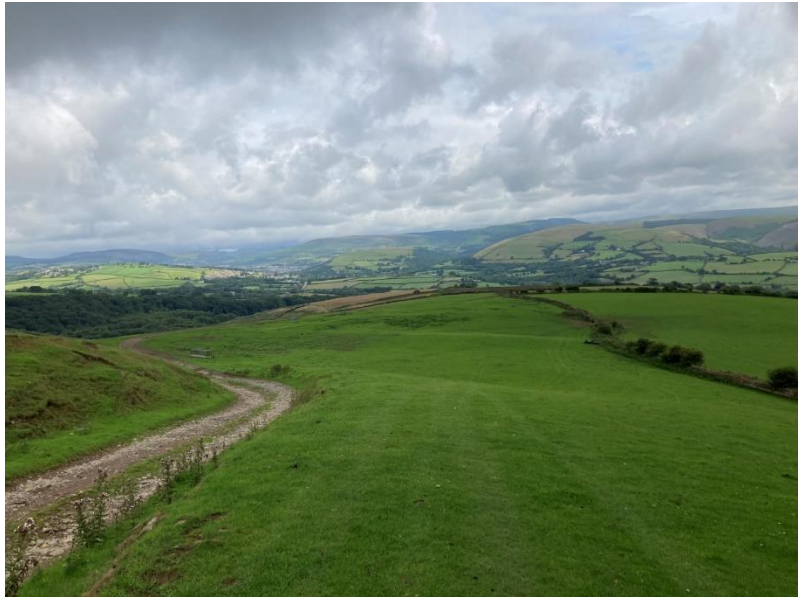
| <b>Photo No.</b><br><br>16 | <b>Date:</b><br>13.07.2023 | |

| Northerly view across field with indicative Turbine #2 location | | |
| <b>Description:</b> Turbine #2<br><br>Fields used for pasture. A stone wall with a gap in between splits the field. Area dips down towards the north and undulates slightly. | | |

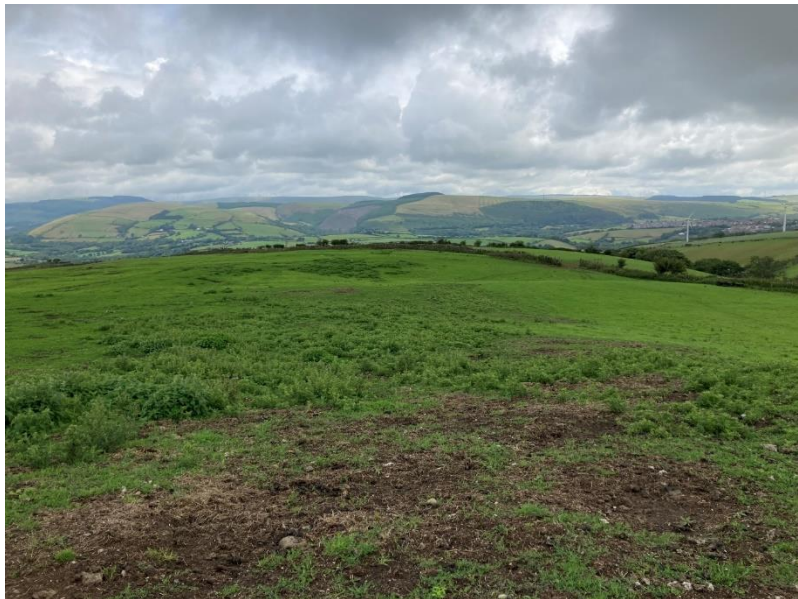
| <b>Photo No.</b><br><b>17</b> | <b>Date:</b><br><b>13.07.2023</b> | |

| North-easterly view across field with indicative Turbine #2 location | | |
| <b>Description:</b> Turbine #7<br><br>View of stone wall with a gap in between splits the field. Fields used for pasture. Area dips down towards the north and undulates slightly. | | |

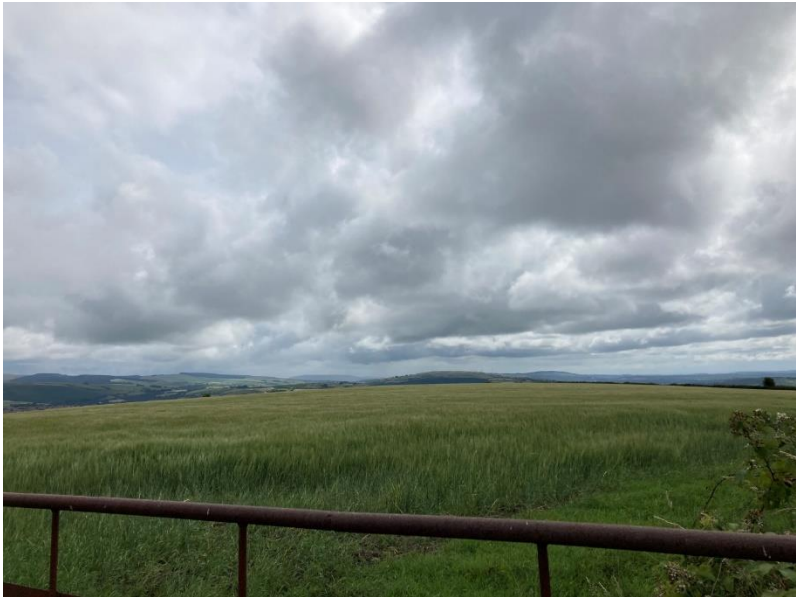
| <b>Photo No.</b><br><b>18</b> | <b>Date:</b><br><b>13.07.2023</b> | |

| Easterly view across field with indicative Turbine #1 location | | |
| <b>Description:</b> Turbine #8<br><br>Field used for crops. Field is relatively level and drops slightly towards the north. | | |

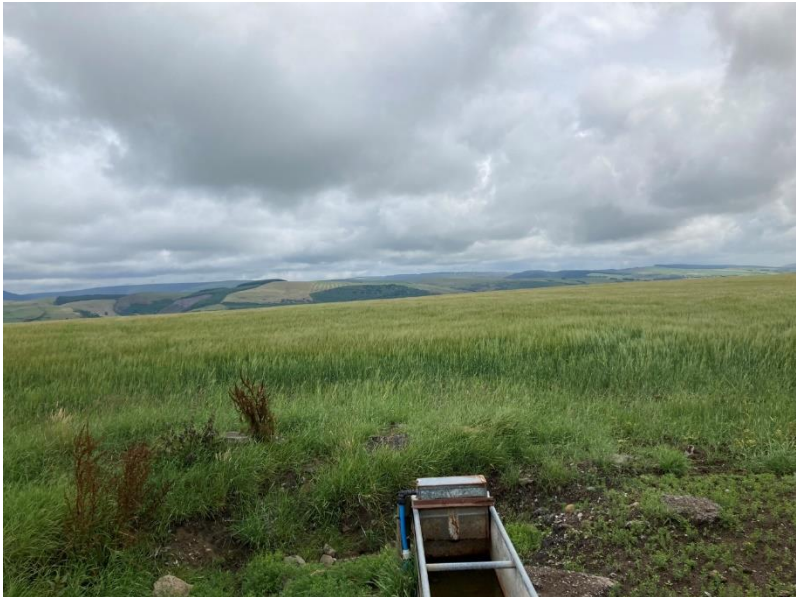
| <b>Photo No.</b><br><b>19</b> | <b>Date:</b><br><b>13.07.2023</b> | |

| Northerly view across field with indicative Turbine #1 location | | |
| <b>Description:</b> Turbine #8<br><br>Field used for crops. Field is relatively level and drops slightly towards the north. | | |

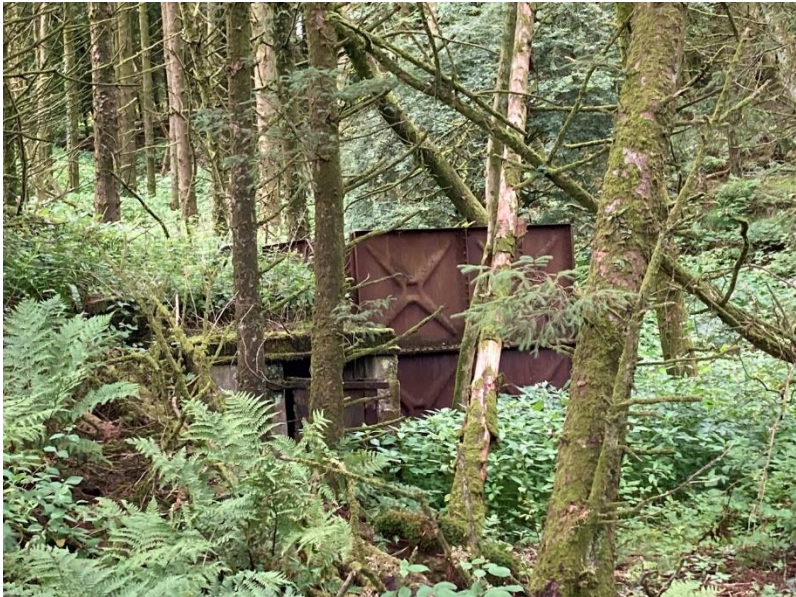
| <b>Photo No.</b><br>20 | <b>Date:</b><br>13.07.2023 | |

| South-westerly view into woodlands at the location of Adit 287185-001. | | |
| <b>Description:</b> Adit-001<br><br>View into wooded area, with possible Adit site entrance and tank structure. | | |

The two Adit were located in woodland surrounded by a fence with barbed wire. These areas could only be observed at the fence perimeter. However, a site entrance (and possible tank structure) could be seen within the vicinity of Adit -001. No associated mine structures were identified within the vicinity of Adit -002, due to dense woodland and the area sitting at a lower elevation.

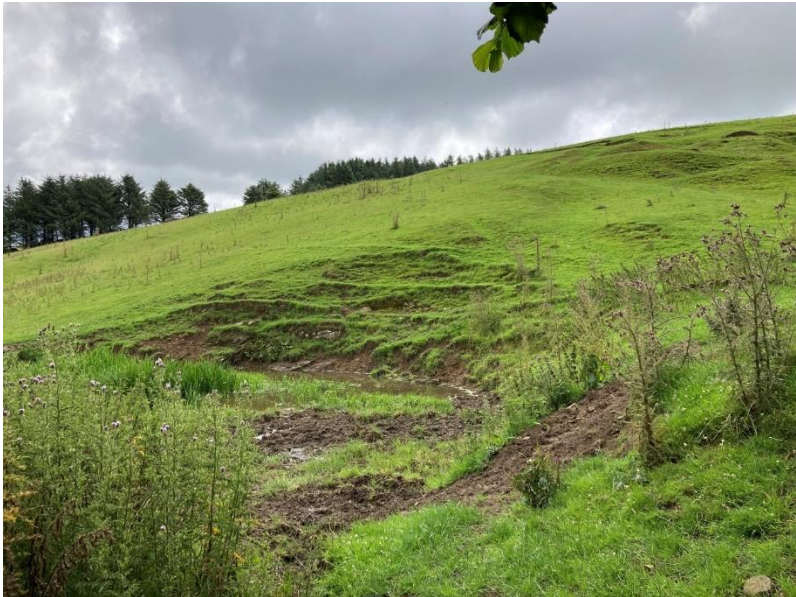
| <b>Photo No.</b><br><b>21</b> | <b>Date:</b><br><b>13.07.2023</b> | |

| Southerly view of area west to Adit 287185-001. | | |
| <b>Description:</b> Adit-001<br><br>Evidence of ground movements in land adjacent to Adit -001.<br>Unknown if associated with mining works or due to general slop stability. | | |

Some evidence of slope erosion at some of the lowest parts of field boundaries. Some notable landslides (slumps) that may be associated with mining works around the two Adits.

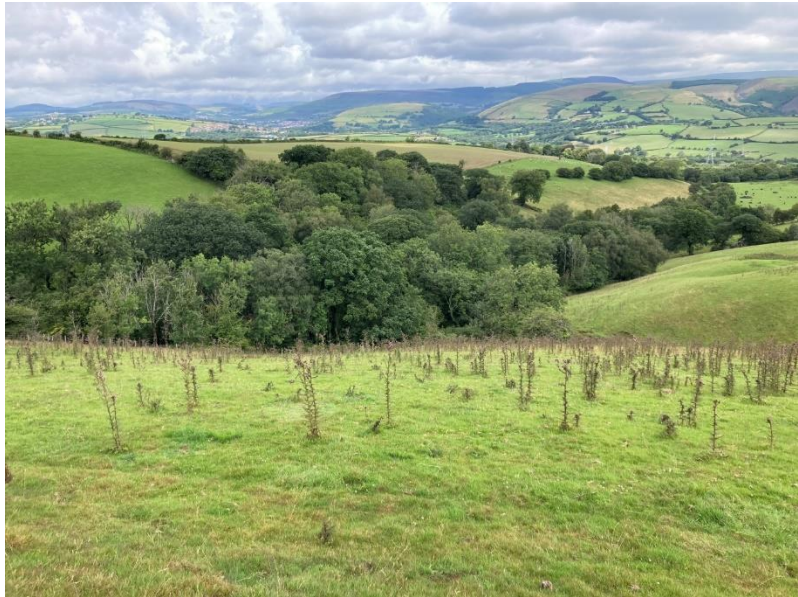
| <b>Photo No.</b><br>22 | <b>Date:</b><br>13.07.2023 | |

| Northerly view into woodlands at the location of Adit 287185-002. | | |
| <b>Description:</b> Adit-002<br>Woodland sitting at low elevation, in approximate direction of Adit 287185-002 (based on GPS co-ordinates). | | |

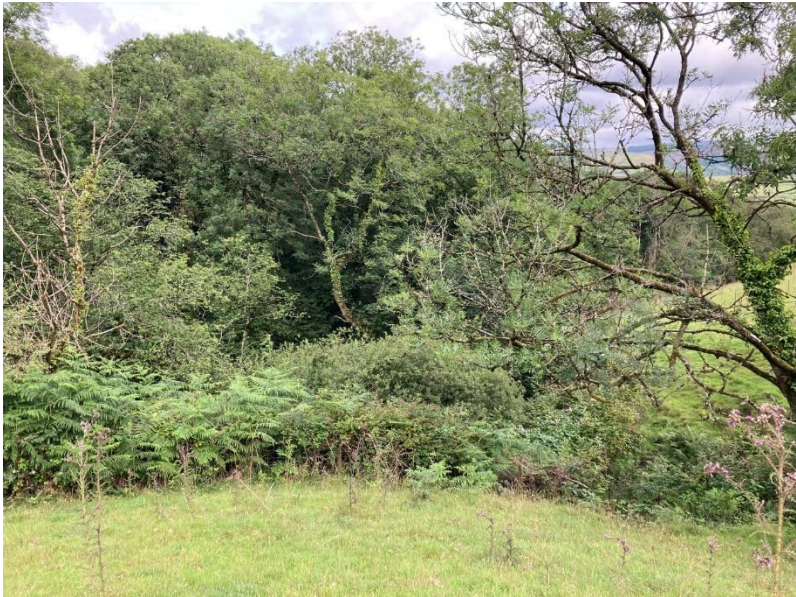
| <b>Photo No.</b><br>23 | <b>Date:</b><br>13.07.2023 | |

| Northerly view into woodlands at the location of Adit 287185-002. | | |
| <b>Description:</b> Adit-002<br>No associated mine structures were identified within the vicinity of Adit -002, due to dense woodland and the area sitting at a lower elevation. Wooded area fenced-off. | | |
